**RE: Need for State Reclamation Permit, B. K. Briggs & Associates, File No. M-2022-027**

**Site 5SA407 - Silver Crown Mine**

### Silver Crown Mine Project Results

**Silver Crown**  
**Report for Second Sampling Event**  
**Third Quarter Sampling - Fall 2022**

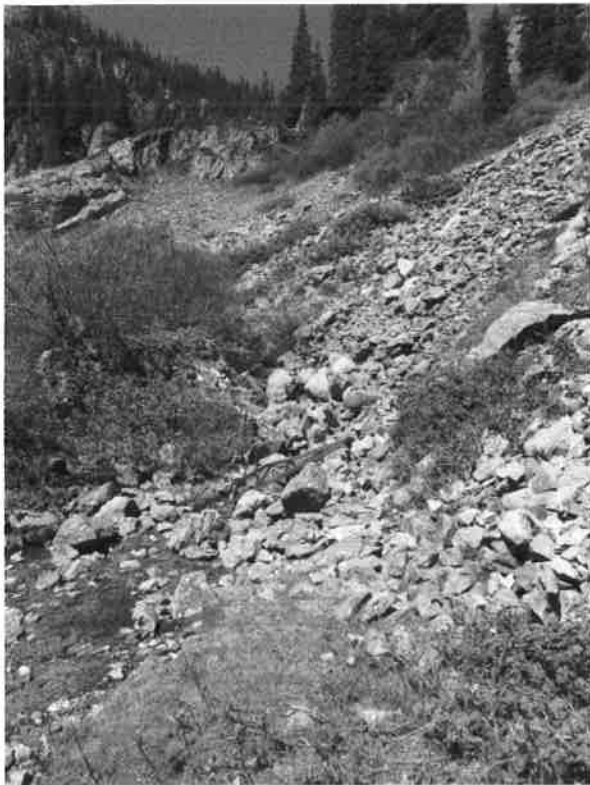
**5SA407.** Collapsed adit with exclusion gate and post and plank framing debris, looking west. Photo by Jon Horn, 6/20/2023.

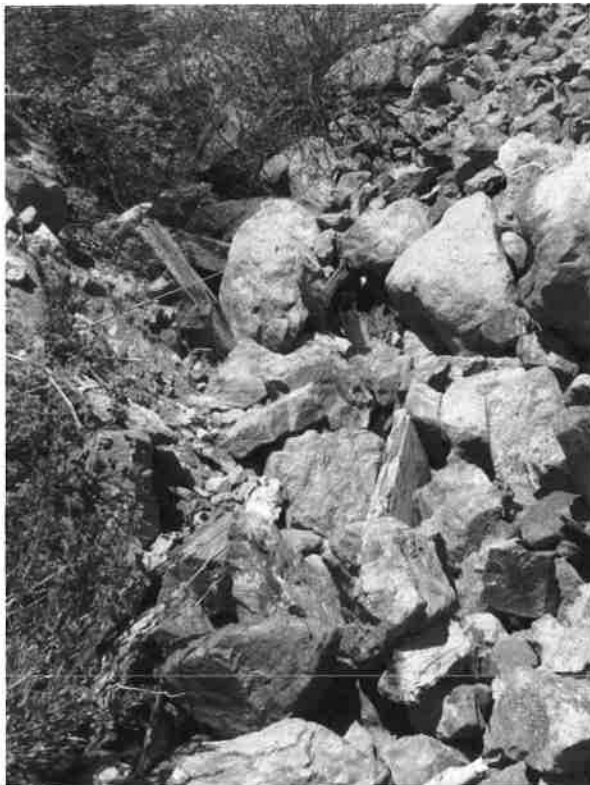
**5SA407.** Looking west at the collapsed adit with post and plank framing debris. Photo by Jon Horn, 6/20/2023.

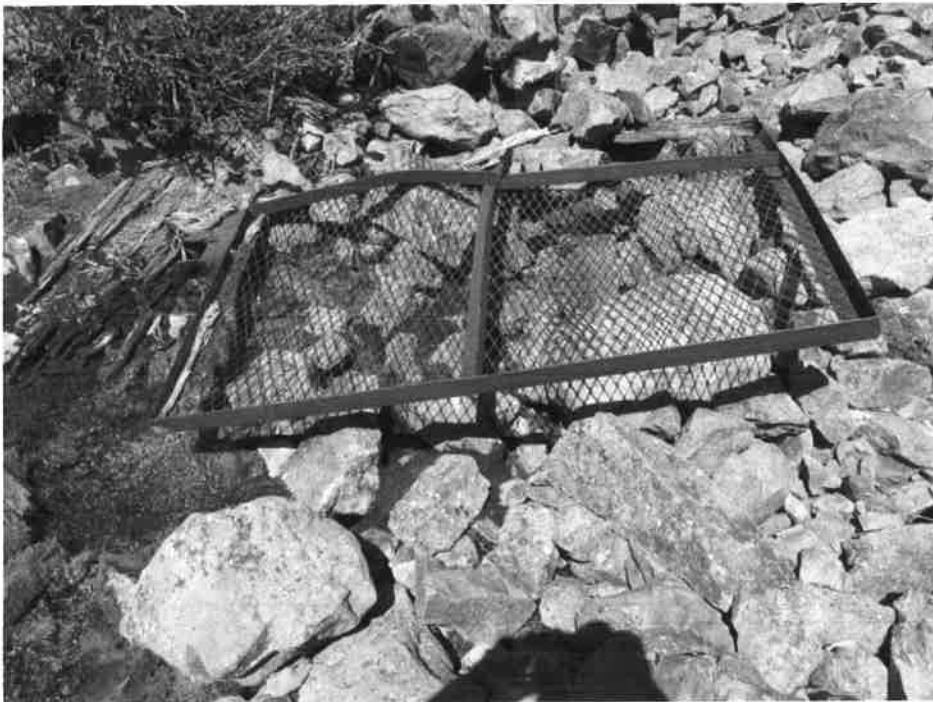
5SA407. Exclusion gate disposed of below the adit. View is to the west. Photo by Jon Horn, 6/20/2023.

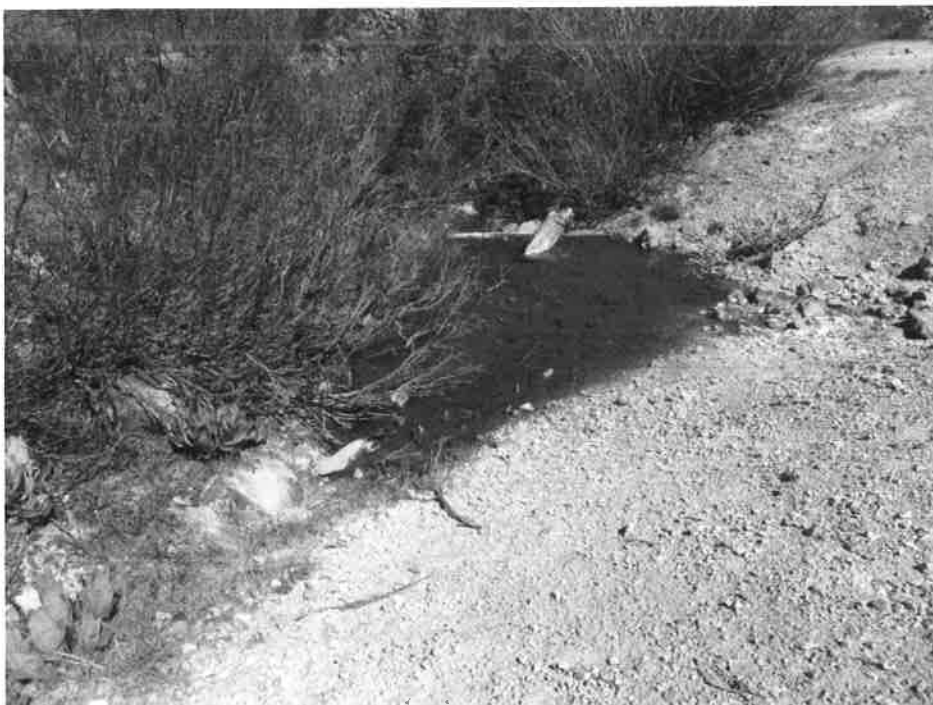
5SA407. Water from the adit ending in a small pond at the upper southwestern edge of the waste rock. View is to the west. Photo by Jon Horn, 6/20/2023.

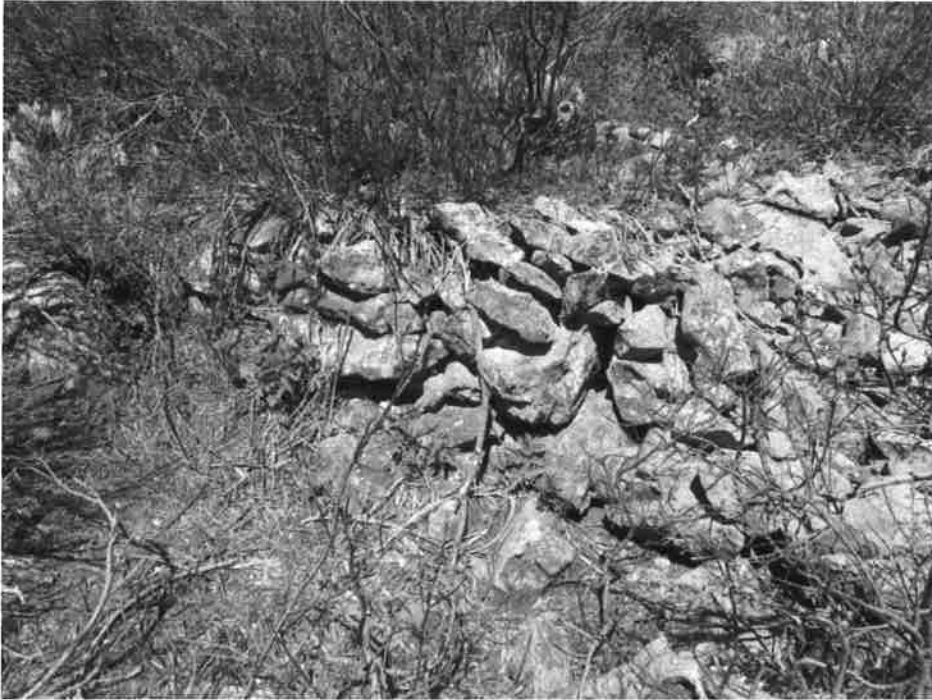
23. **Describe condition:** No buildings remain standing on the site. Deteriorated stone retaining walls are present at the base of the slope above the top of the waste rock that provided space for mine buildings. Two machinery mounts are present and a remnant of a board floor has survived. The mine adit has collapsed. Two rock wall avalanche deflectors remain in very good condition.

5SA407. Looking west at the southernmost retaining wall. Photo by Jon Horn, 6/20/2023.

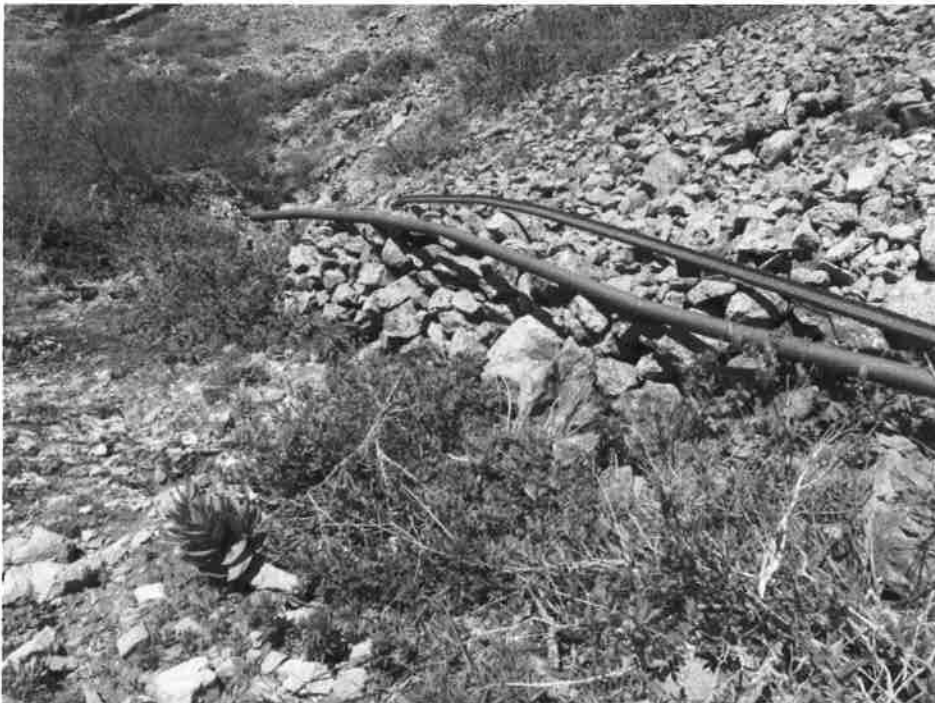
5SA407. Looking west at the central retaining wall remnant with ore car rail and compressed air pipe disposed on it. Photo by Jon Horn, 6/20/2023.

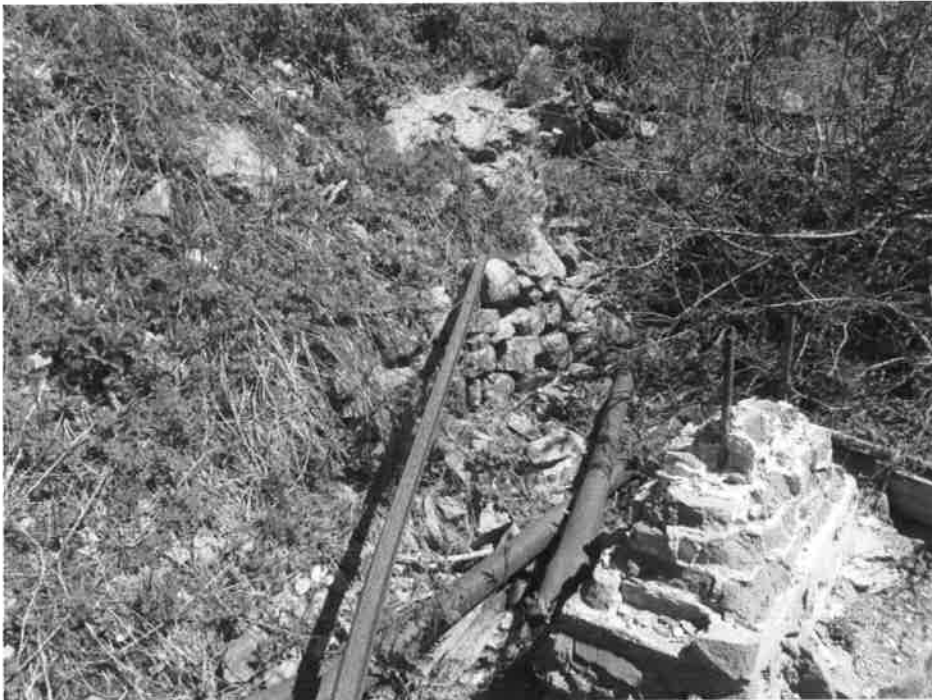
**5SA407.** Northernmost stone retaining wall remnant behind probable electric motor mount. View is to the north.  
Photo by Jon Horn, 6/20/2023.

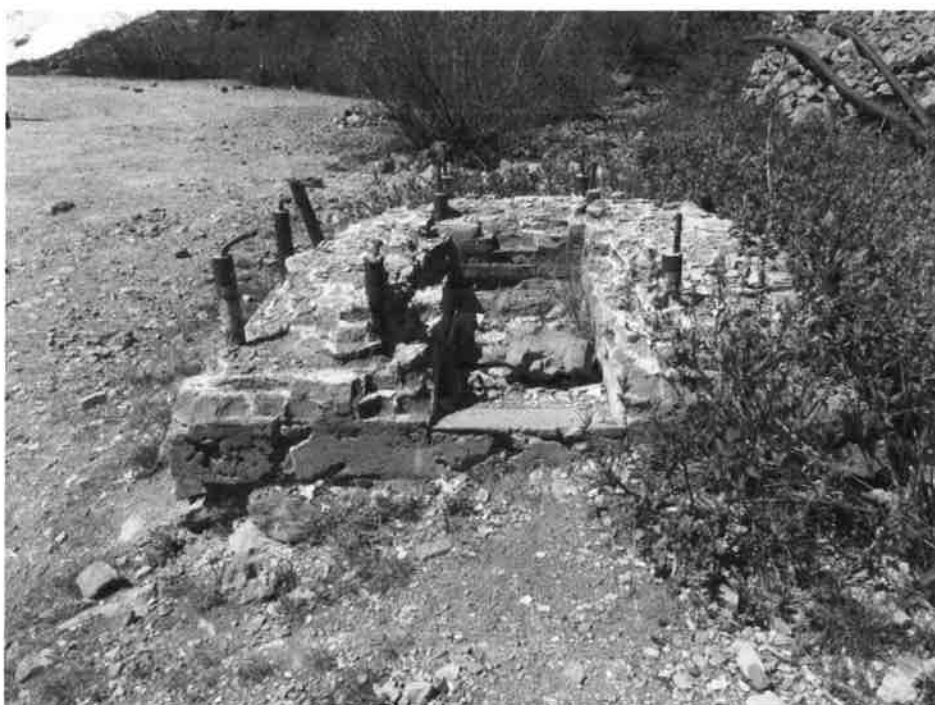
**5SA407.** Stone, cement, and brick compressor mount, looking south-southwest. Photo by Jon Horn, 6/20/2023.

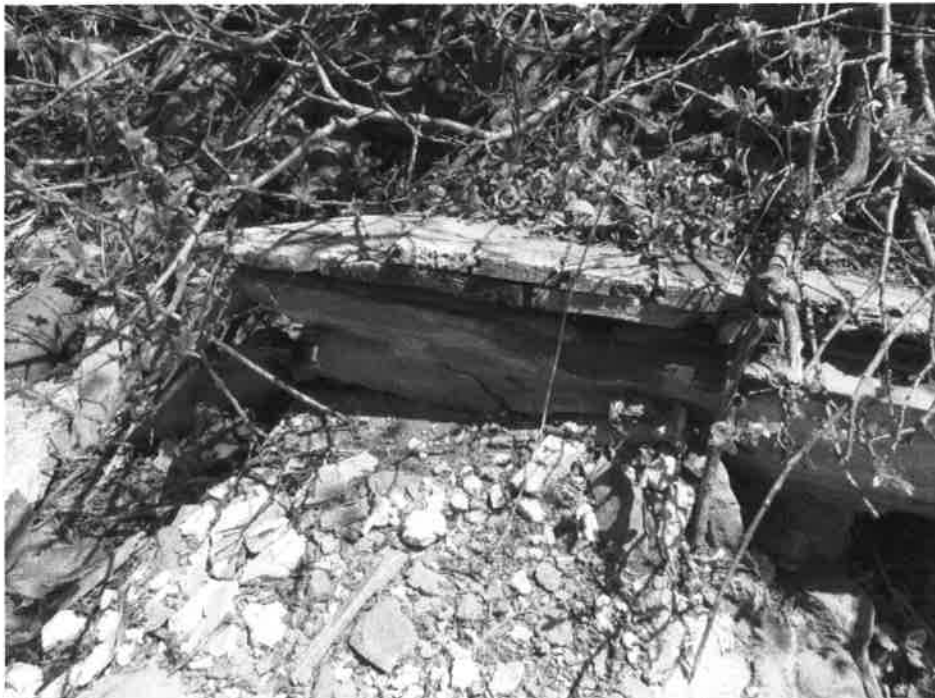
**5SA407.** Building floor remnant showing diagonal 1-x-6-in. subfloor topped by 1-x-4-in. tongue and groove flooring set on 3 by 6-in. joist. View is to the north. Photo by Jon Horn, 6/20/2023.

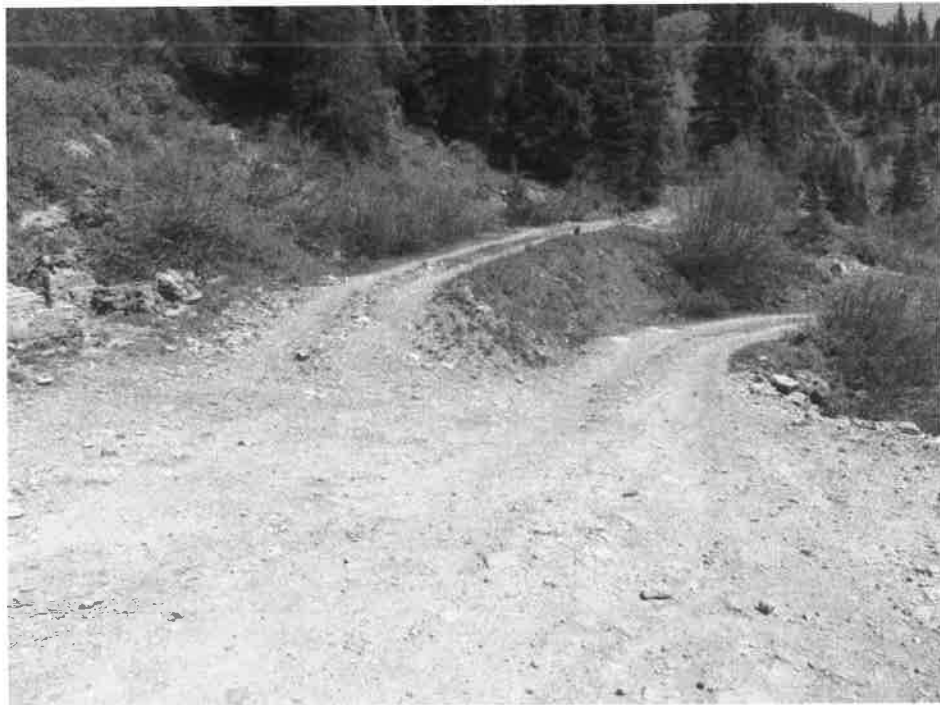
**5SA407.** Road switchback that has removed the boarding house/office and pushed it and artifacts downslope. View is to the north. Photo by Jon Horn, 6/20/2023.

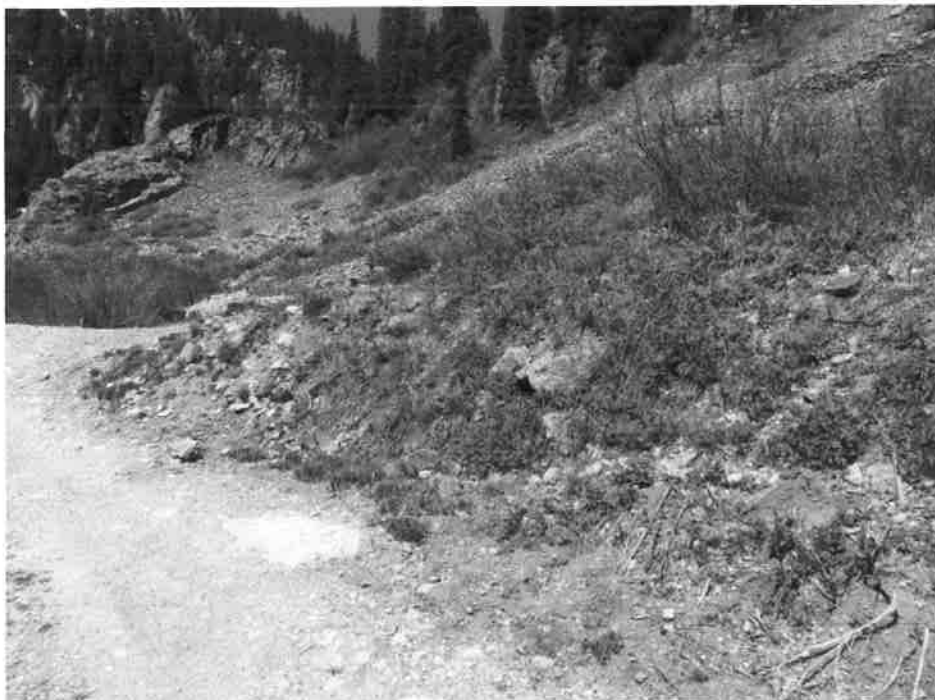
5SA407. Looking southwest at the cut bank below the road switchback that contains heavily disturbed artifacts. Photo by Jon Horn, 6/20/2023.

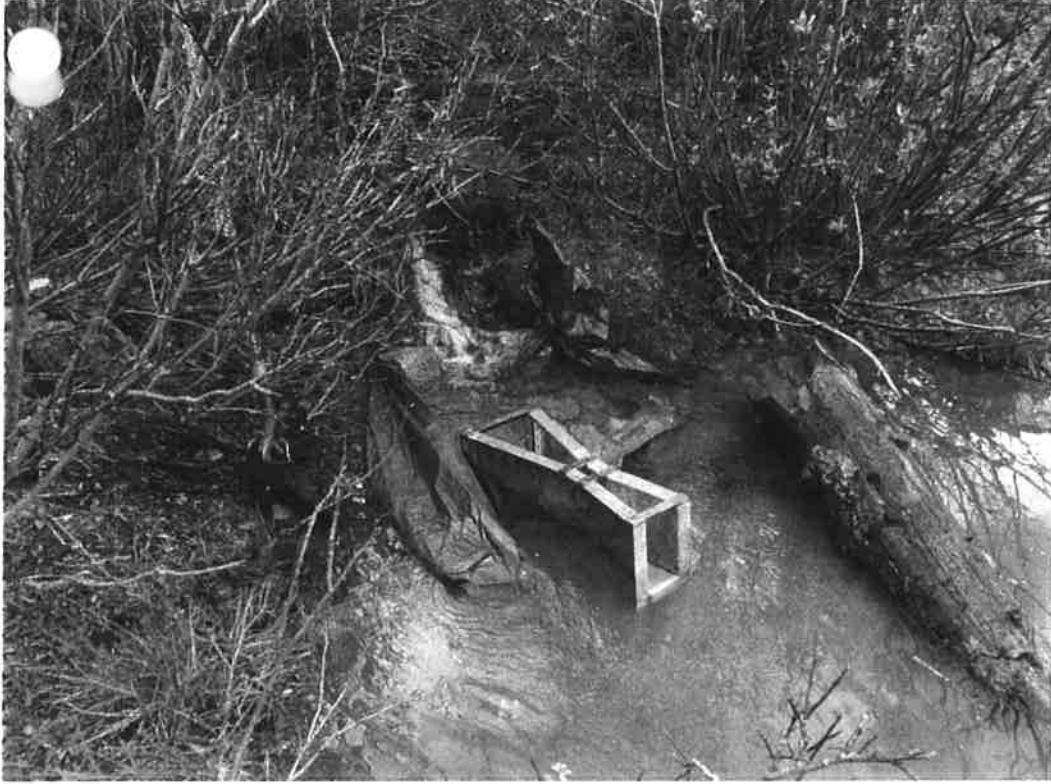
Adit Discharge volume location. Discharge was gathered (during measurement) into a 1-inch portable Parshall flume was utilized for accuracy.

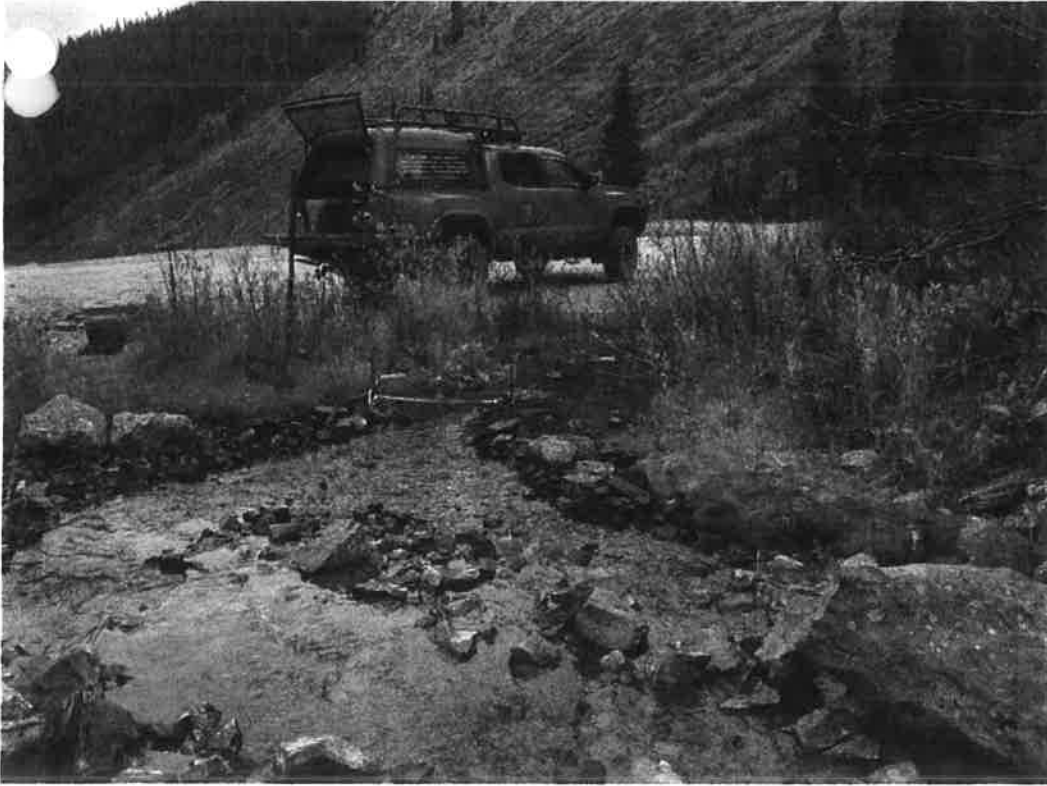
Above WSW attempted to gage flow from Adit, but volume too low for pygmy meter.  
Had to use Parshall flume.

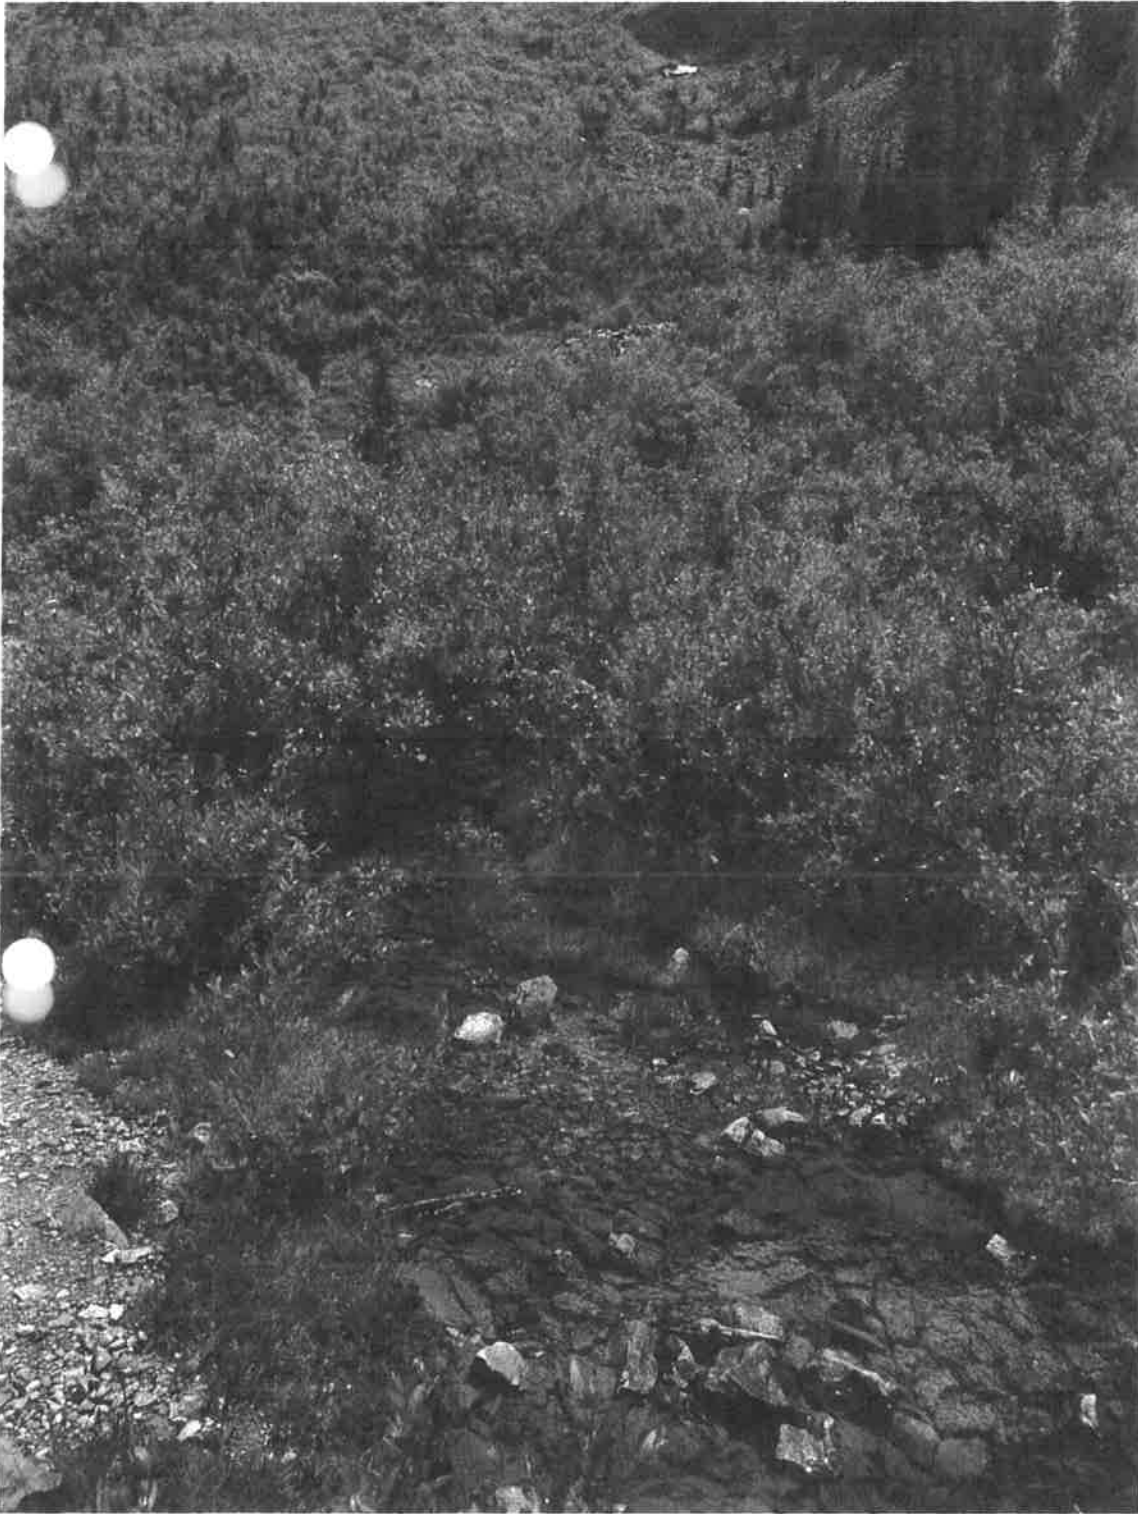
Below existing wetlands there is less indication of iron hydroxide noticeable in an alluvial deposit. Wetlands are a remarkably effective passive treatment for mine discharge.

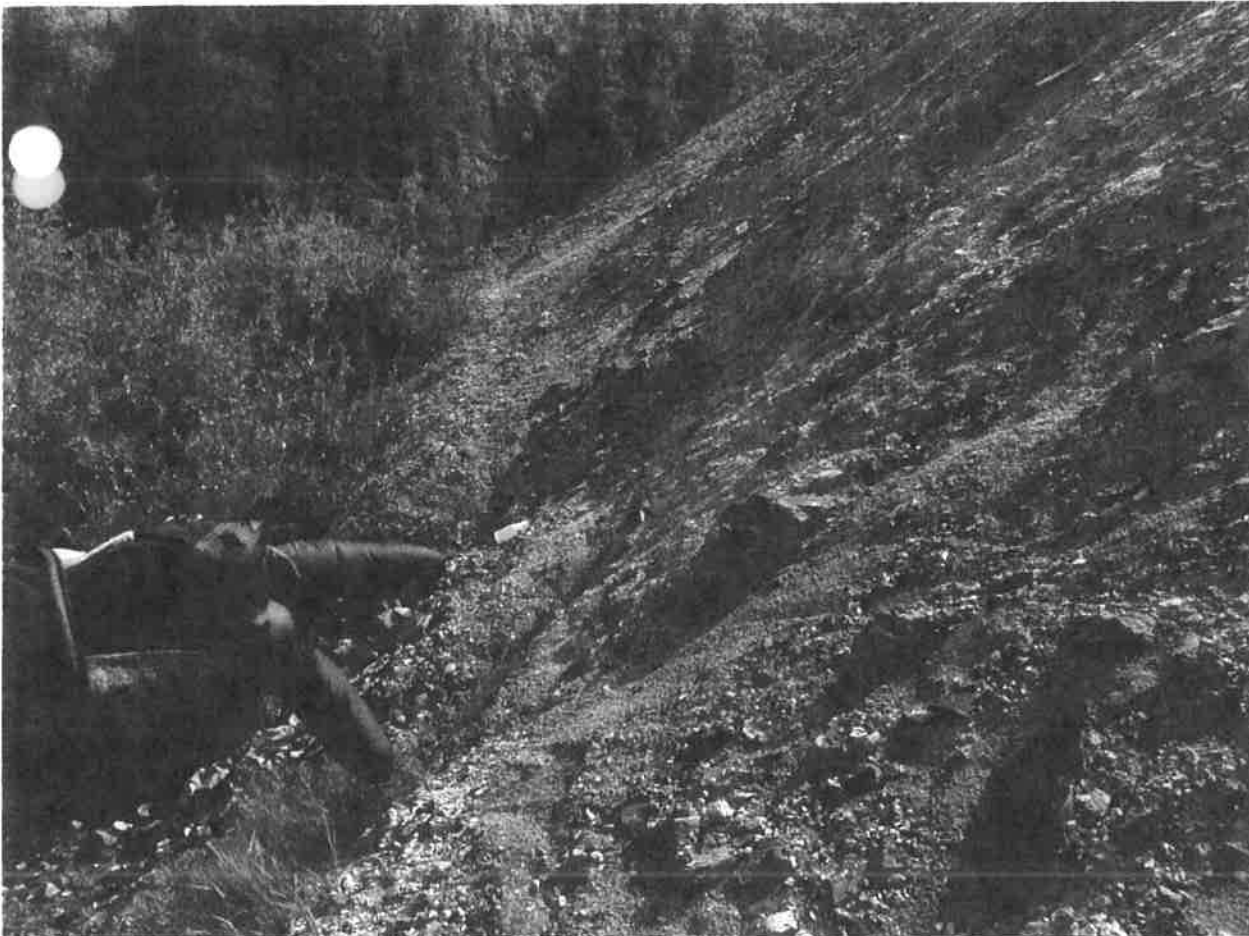
**W pointing to the two separate discharge locations at the base of the tailings pile. It was deemed prudent to sample at both locations, though close in proximity, as they appear to originate from different source material with potentially different water quality considerations.**
