Subject: Application for Improvement Permit – Sketch Plan Review

Proposed Careaga Cabin located at TBD County Road 99, Sandusky Lode, MS #1345A, near Picayune Gulch, San Juan County, Colorado.

Careaga Cabin

RE: Avalanche Hazard Assessment
Sandusky Lode, Eureka Mining District, USMS # 1345A
Assessor Parcel No. 47730070050008
County Road 99, Picayune Gulch, San Juan County, Colorado

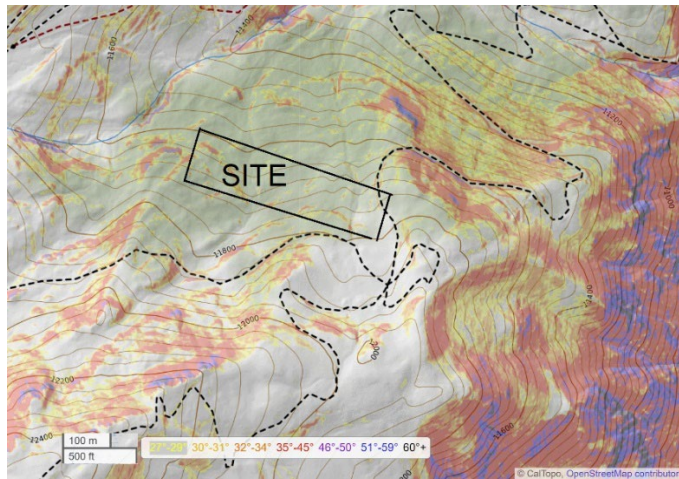
Figure 2 – Site on Caltopo Slope Map
(Site boundaries are approximate)

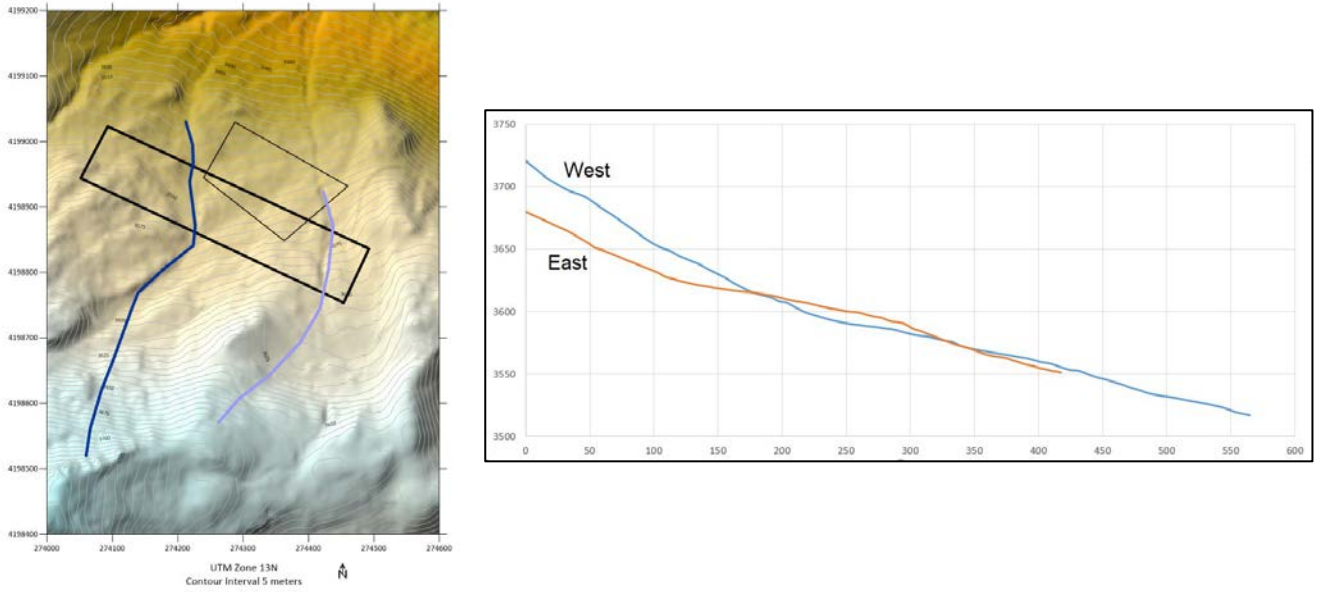
Figure 5 – Profiles of Avalanche Paths affecting the Site

The site is located just below timberline in the Picayne Gulch basin near elevation 3580 meters. We identified two generalized north-facing avalanche starting zones³ with the potential to reach the site. The larger western starting zone is between 3720 and 3650-meters elevation. The smaller east starting zone is between 3680 and 3630 meters. Figure 5 shows avalanche path profiles and their locations. Both starting zones are above timberline and can be strongly affected by wind loading from southwest flows. The west starting zone has a potential release area of about 2.2 hectares with a mean slope angle of 33 degrees and northerly aspect. The east starting zone has a potential release area of about 0.7 hectares and mean slope angle of 30-degrees, also with a northerly aspect. Most avalanches in the east path will stop on the 6-8-degree sloping bench near elevation 3610 meters, but the design magnitude avalanche will cross the site. Figure 6 shows a slope angle map of the avalanche terrain derived from LiDAR data. Figure 7 shows a slope aspect map.

The East and West avalanche paths have weak to moderately channelized tracks⁴ and flow off-site with slope of about 18-20-degrees below the site. The total vertical elevation drops to the upper site limits of the West and East paths are about 160 meters and 80 meters, respectively. The runout zone⁵ for the West path is near elevation 3450 at Picayne Creek and the East path design-magnitude avalanche will stop in forested terrain near elevation 3540 meters.

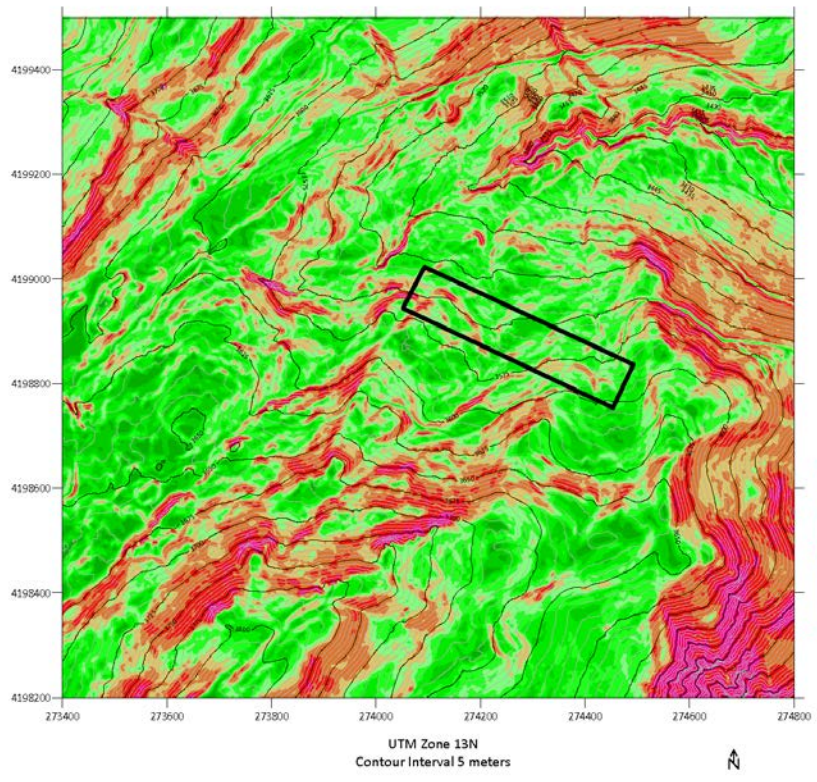
Figure 6 – LiDAR Slope Angle Map
(Site boundary approximate)

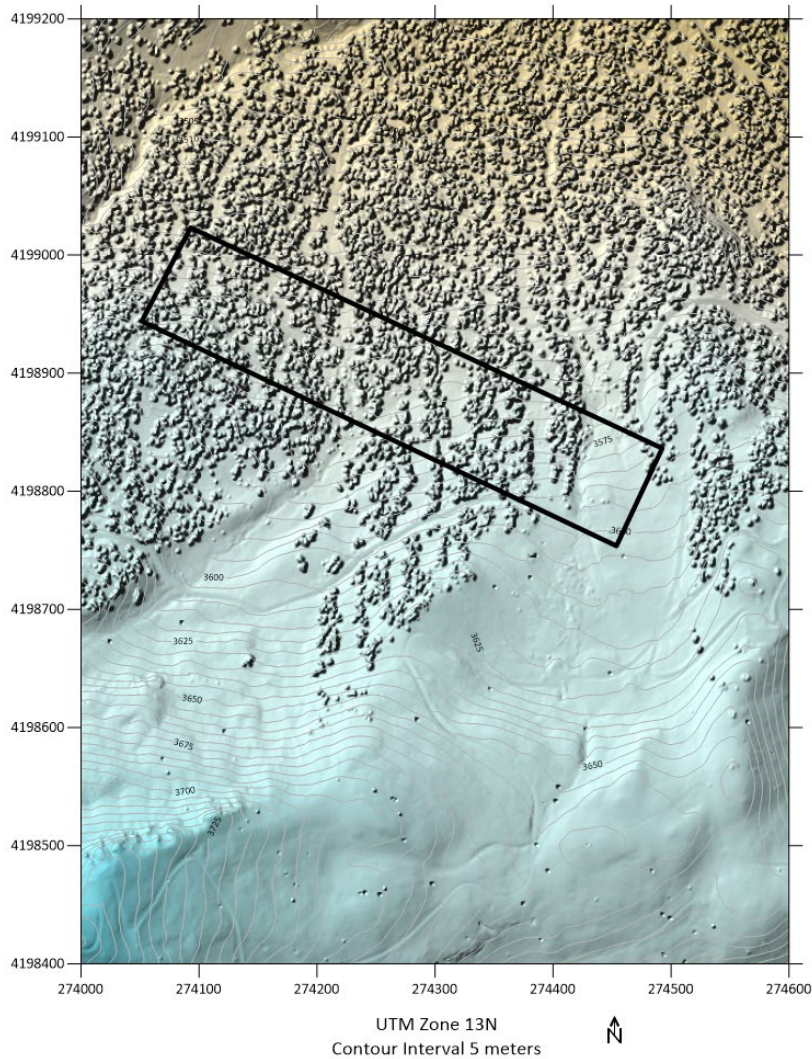
Figure 8 – Vegetation and Non-ground LiDAR Reflections
(Site boundary approximate)

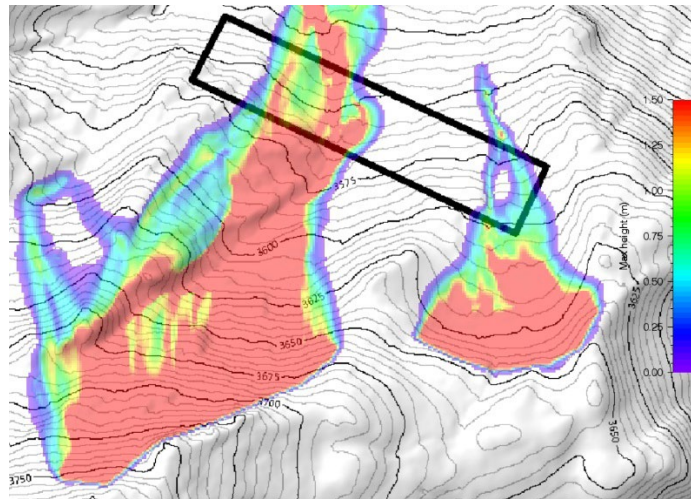
Figure 9 – RAMMS Run 10 Predicted Maximum Flow Heights

We used the Swiss avalanche dynamics program RAMMS Release 1.7.20 to evaluate flow directions, thickness and velocities for the design-magnitude avalanche. Figure 10 shows representative model results for the maximum flow heights for the design-magnitude avalanche, Figure 10 shows predicted maximum velocities. The model calibration was based on our experience with other avalanches in Colorado, including well-documented historic avalanches and regional runout statistics. Model assumptions and parameters for the design magnitude avalanche are presented in Appendix A.

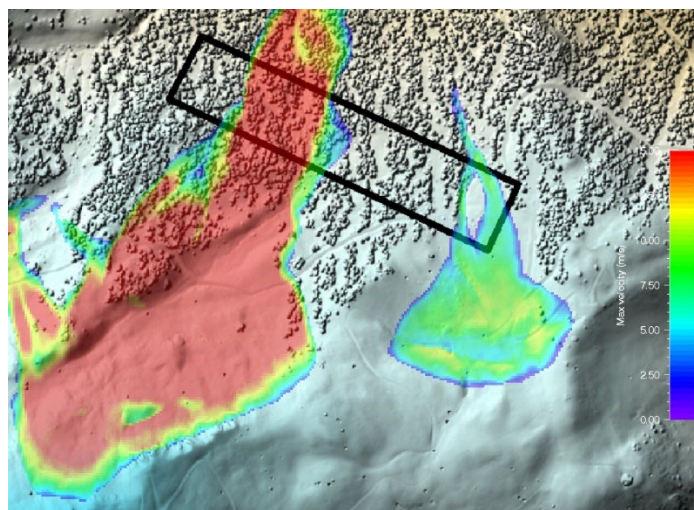
Figure 10 – RAMMS Run 10 Predicted Maximum Velocities

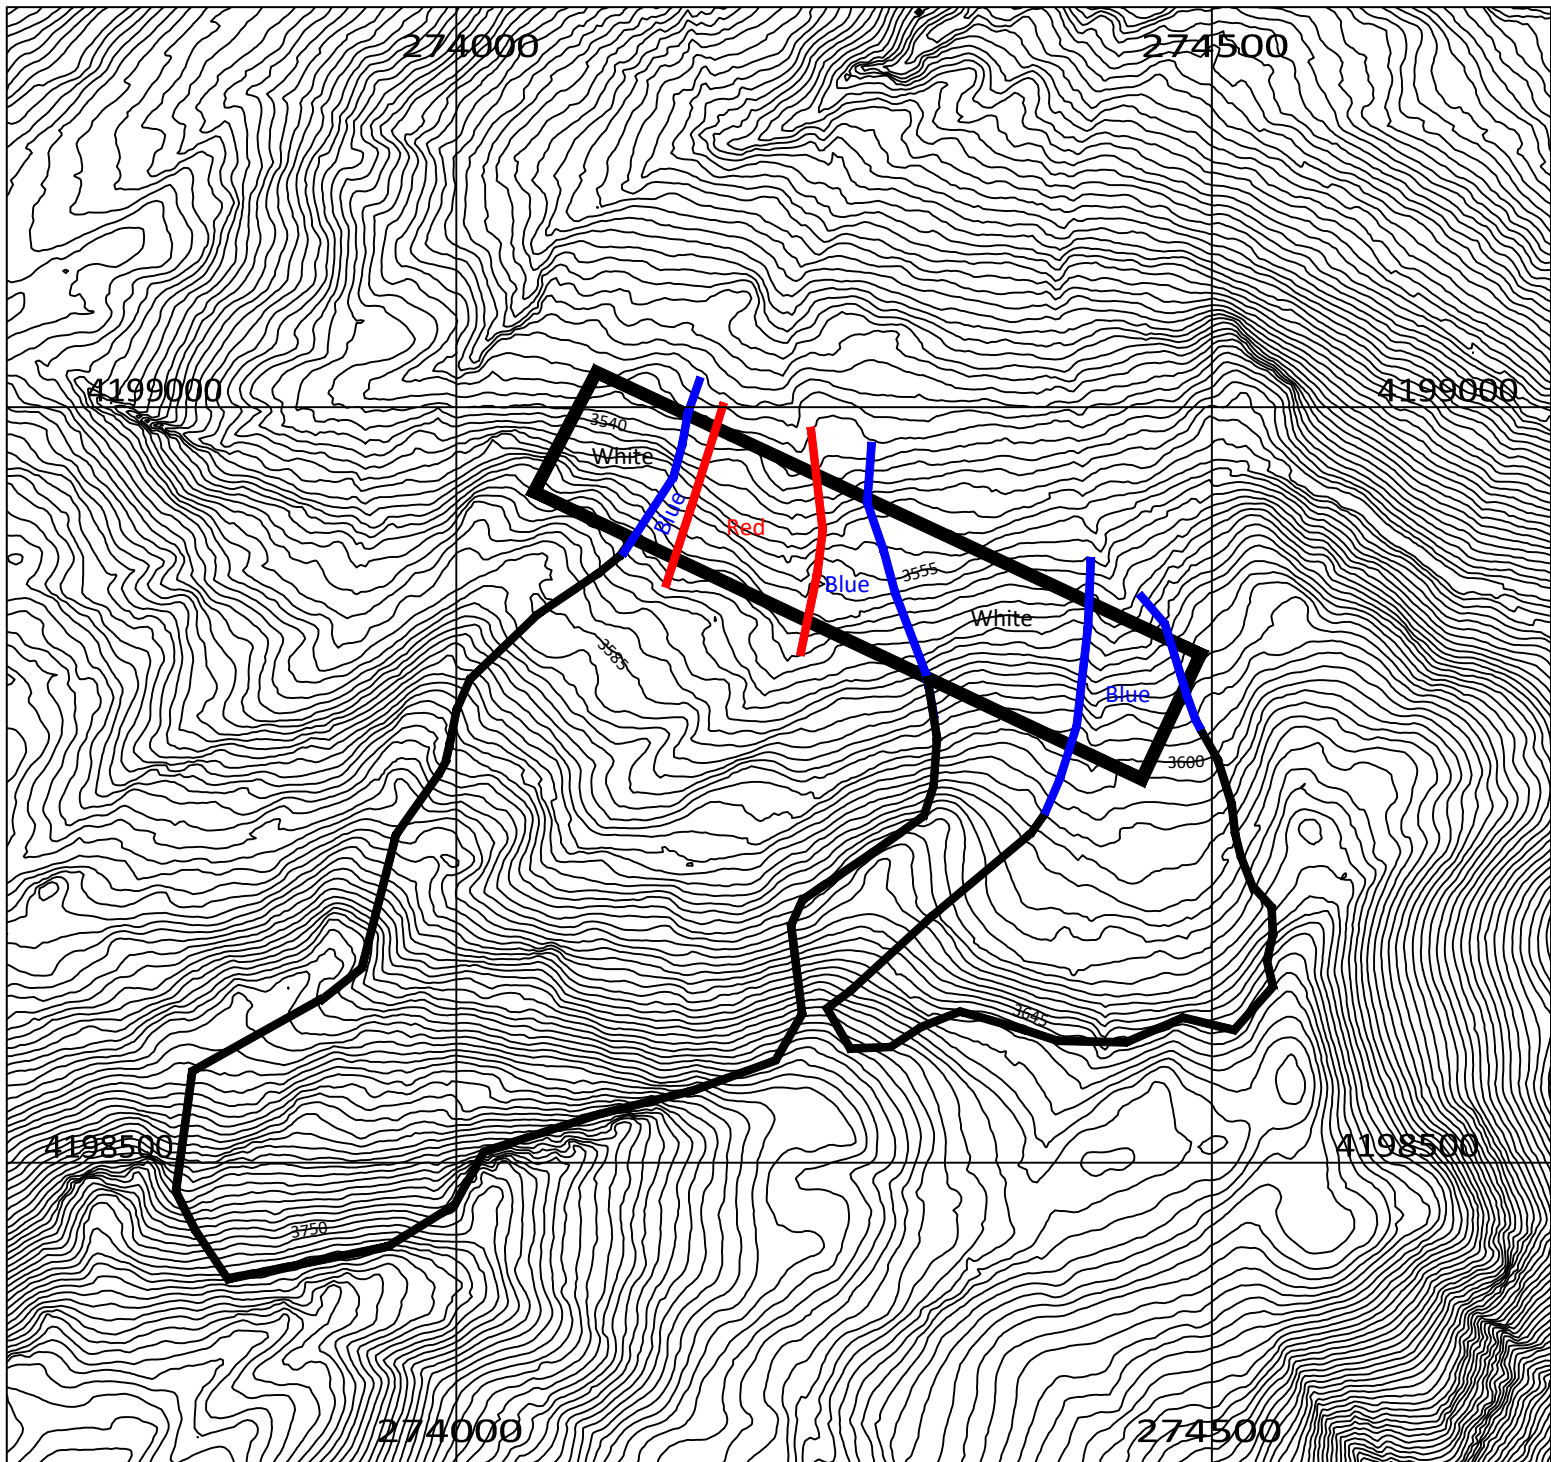
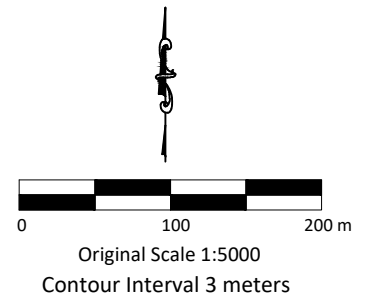
1. High (Red) hazard zone - area where avalanches can be destructive *and/or* frequent; these are areas where avalanches have average return periods of 30 years of less *and/or* can produce impact pressures of 600 pounds per square ft (psf) or more on flat surfaces normal to the flow.
2. Moderate (Blue) hazard zone - area where avalanches are not as frequent and are less destructive than in the high-hazard zone; these are areas where avalanches have average return periods of 30 to 100 years *and* produce impact pressures of less than 600 pounds per square ft (psf).
3. White zone - areas outside the avalanche hazards zones defined above.

Figure 11 - Avalanche Hazard Map

Based on the observations, analyses and methods described in this report, we developed the Avalanche Hazard Zone Map shown in Figure 11. The Moderate Hazard Zone (or Blue Zone) represents an area of low frequency avalanches and low to moderate impact pressures. The High Hazard (or Red Zone) is also shown in Figure 11. This represents an area that includes frequent avalanches (less than 30-year average return periods) and areas where the design-magnitude avalanche impact pressures

1. Avoidance of avalanche hazards is the most reliable form of mitigation. If practical, we recommend placing structures outside of the Blue and Red Avalanche Hazard Zones.

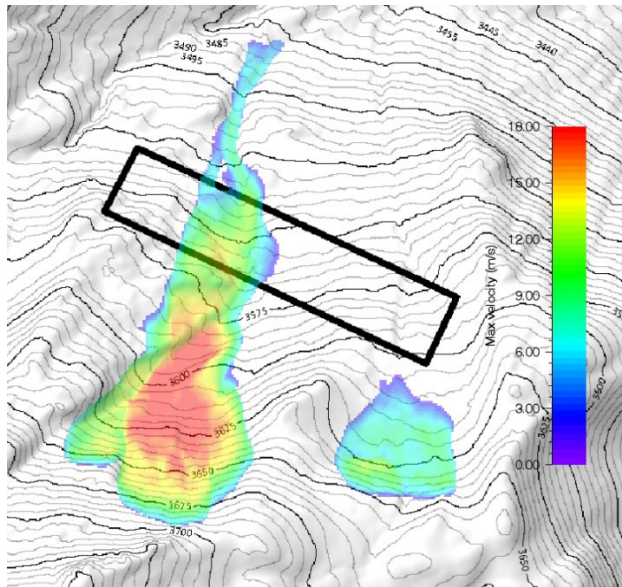
Run 3 – Maximum Velocities

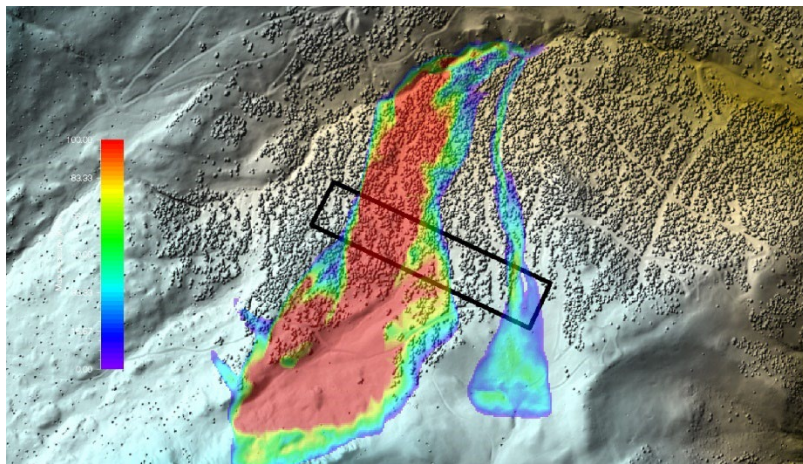
Run 7 – Maximum Pressure

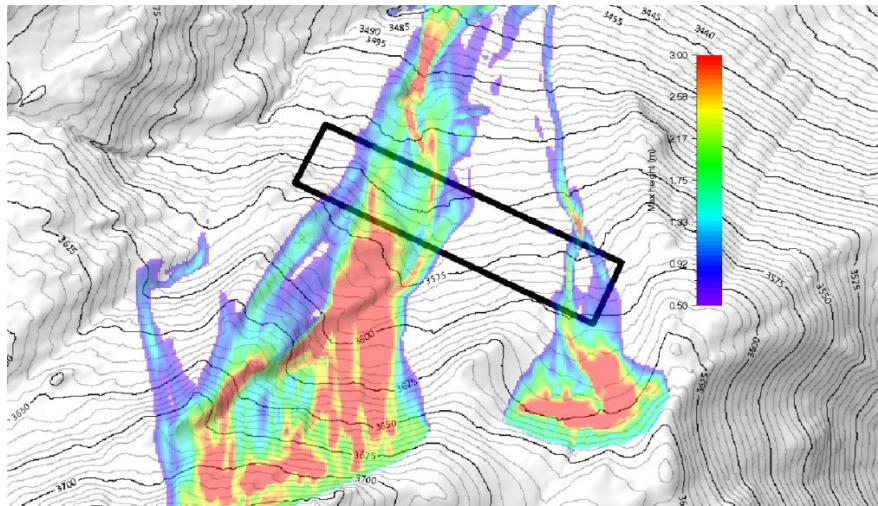
Run 8 – Maximum Flow Height

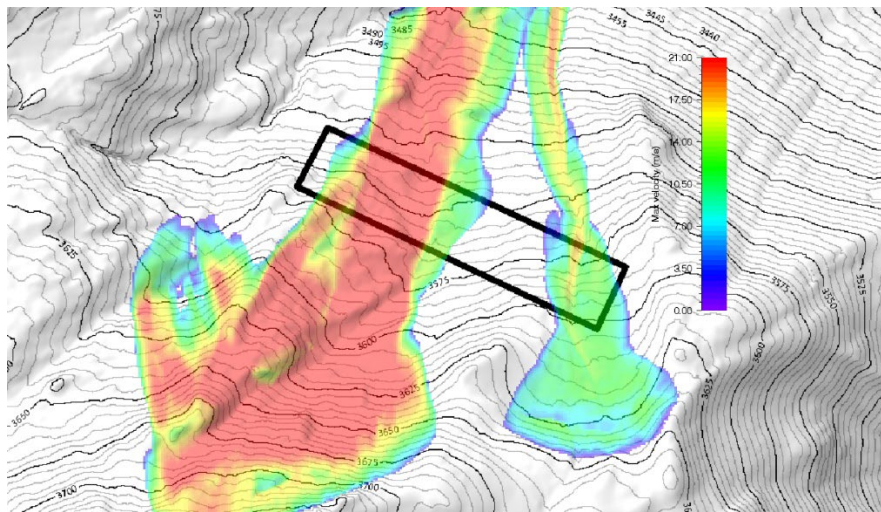
Run 8 – Maximum Velocity

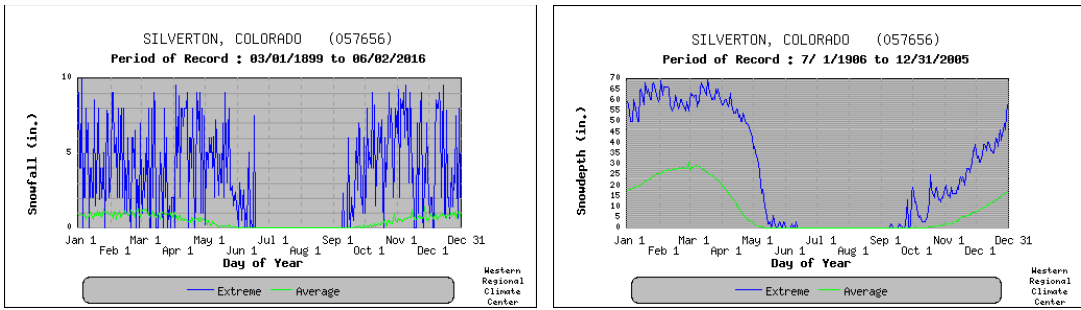
Silverton Coop Snow Height and 24-hour Snowfall Data

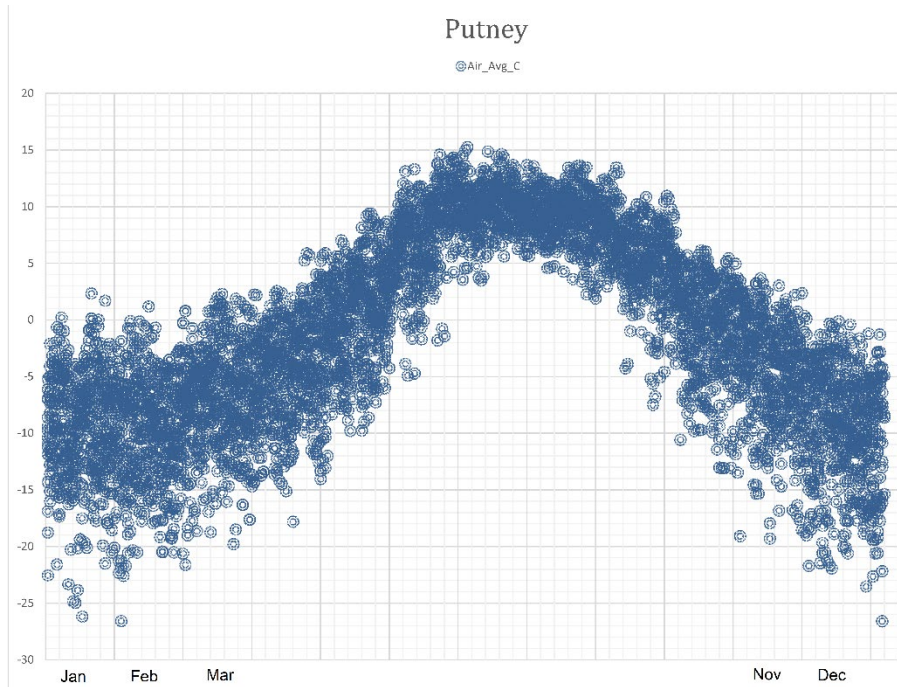
Putney Air Temperatures
(data courtesy of the Center for Snow and Avalanche Studies)

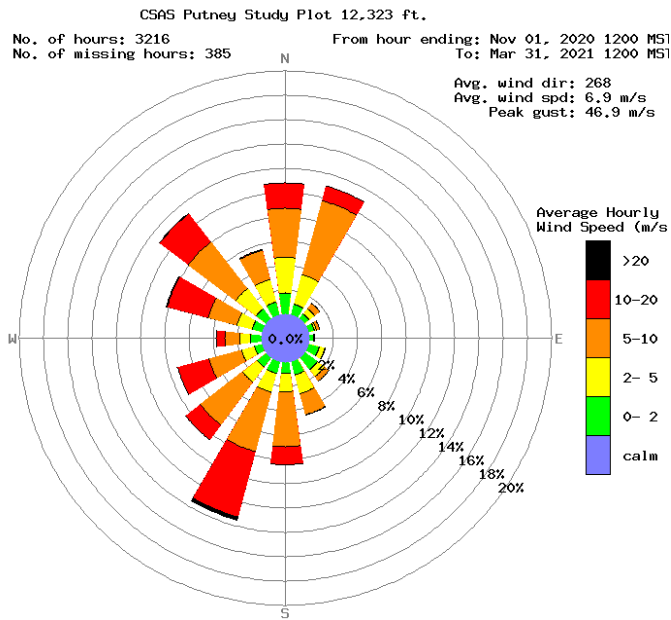
Putney Wind Rose
 (data courtesy of the Center for Snow and Avalanche Studies)

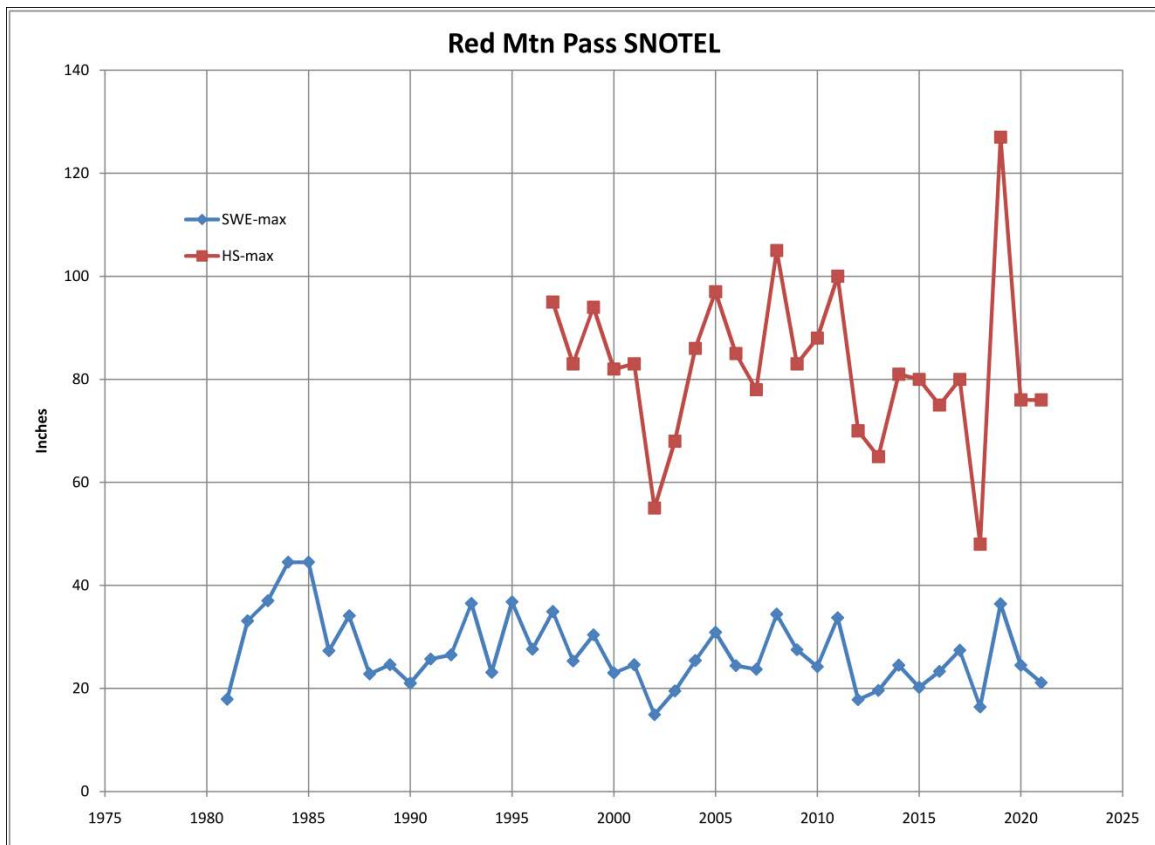
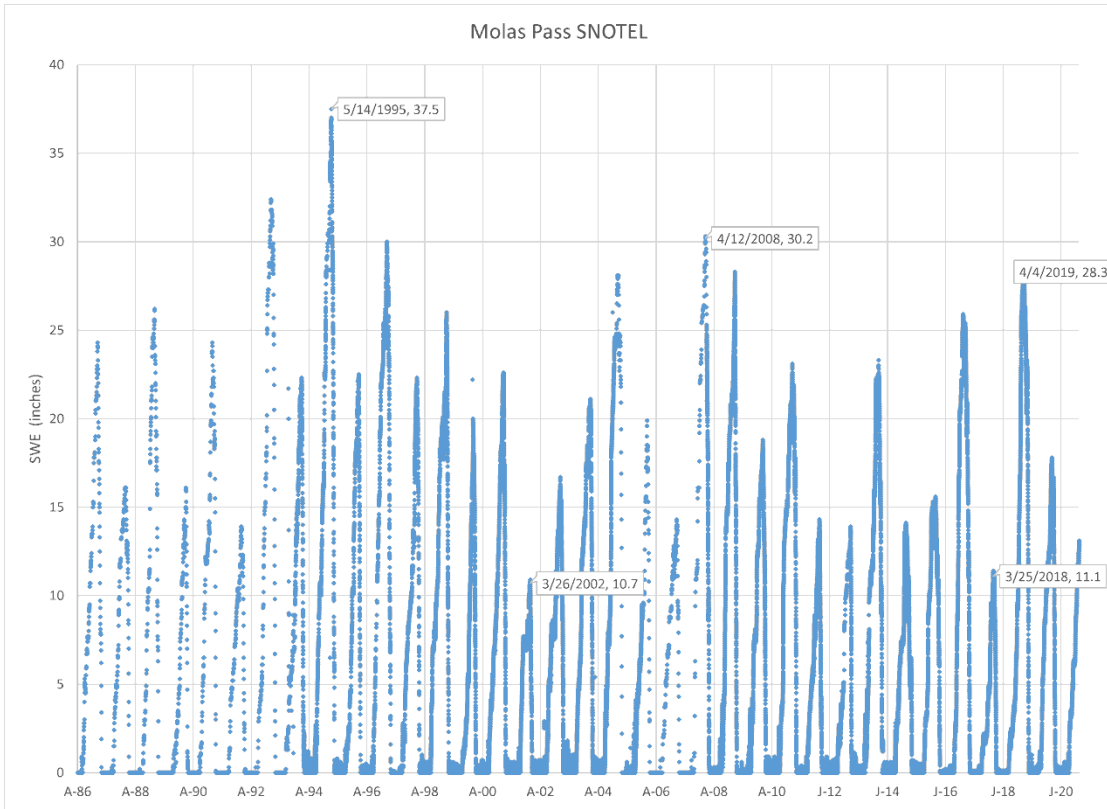
Molas SNOTEL Snow Water Equivalent
(El. 3200 meters)

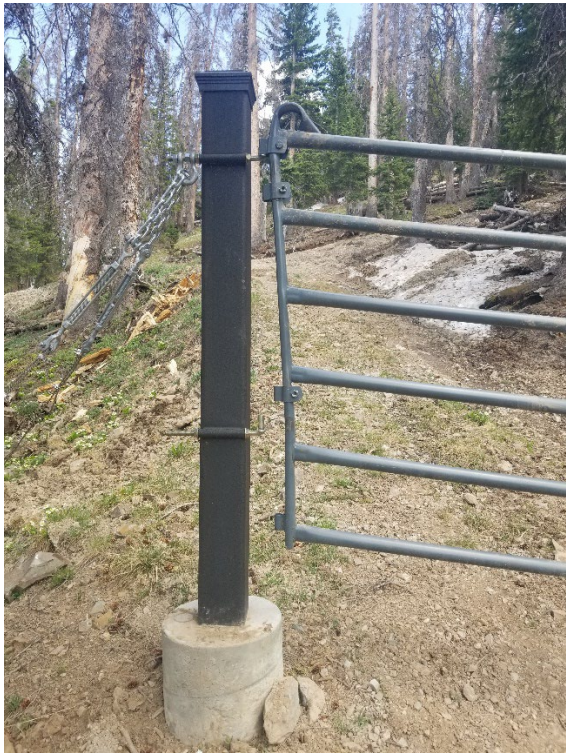
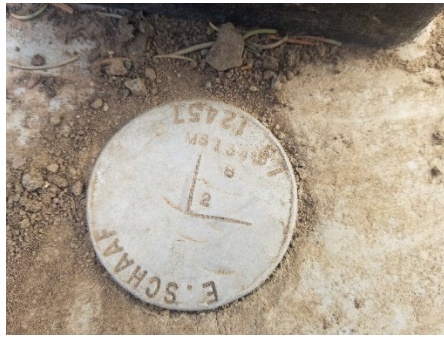
Gate damaged by snow creep
Survey pin in post foundation
