Application for Improvement Permit

LAND USE PERMIT
San Juan County, Colorado

CASCADE MEADOWS SUBDIVISION
For Application for Improvement Permit

CASCADE MEADOWS
SUBDIVISION
CASCADE VILLAGE
TRACT A-1 & TRACT B-1
S13, T39N, R9W, N.M.P.M.
SAN JUAN COUNTY, COLORADO

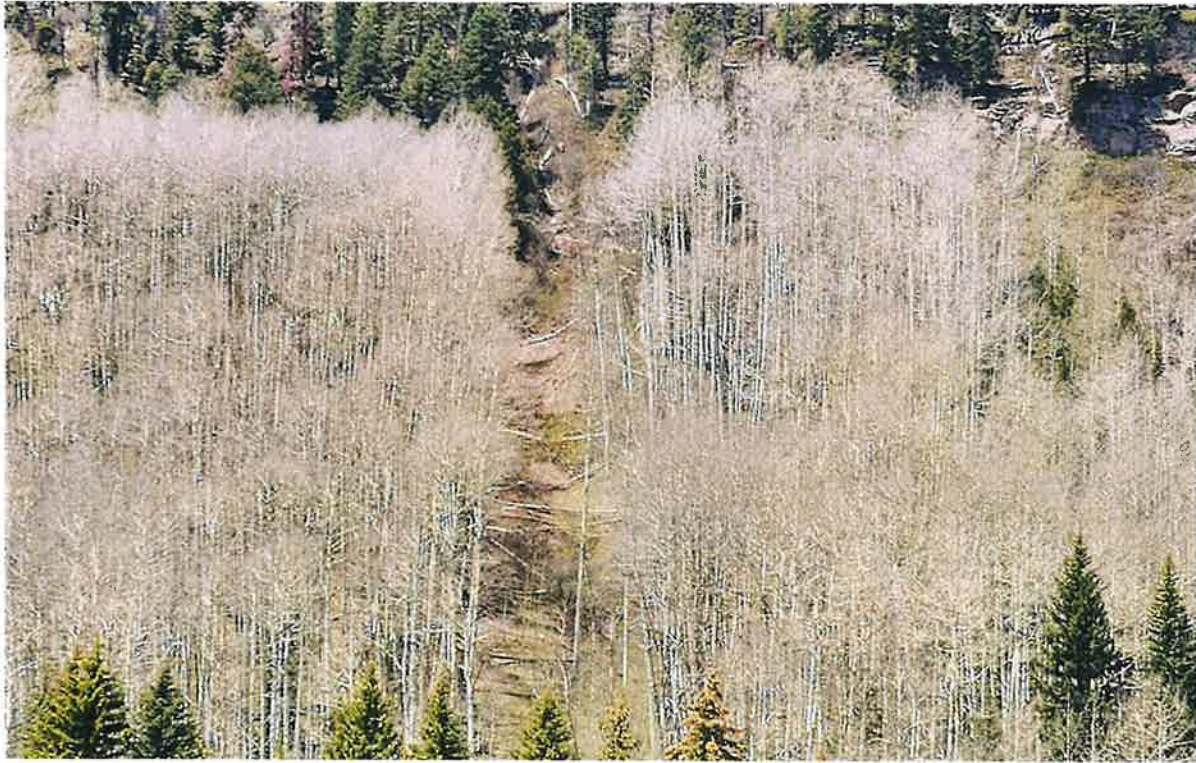
Photograph 1: View of potential avalanche slide path at south end of site looking west from N. US Highway 550.

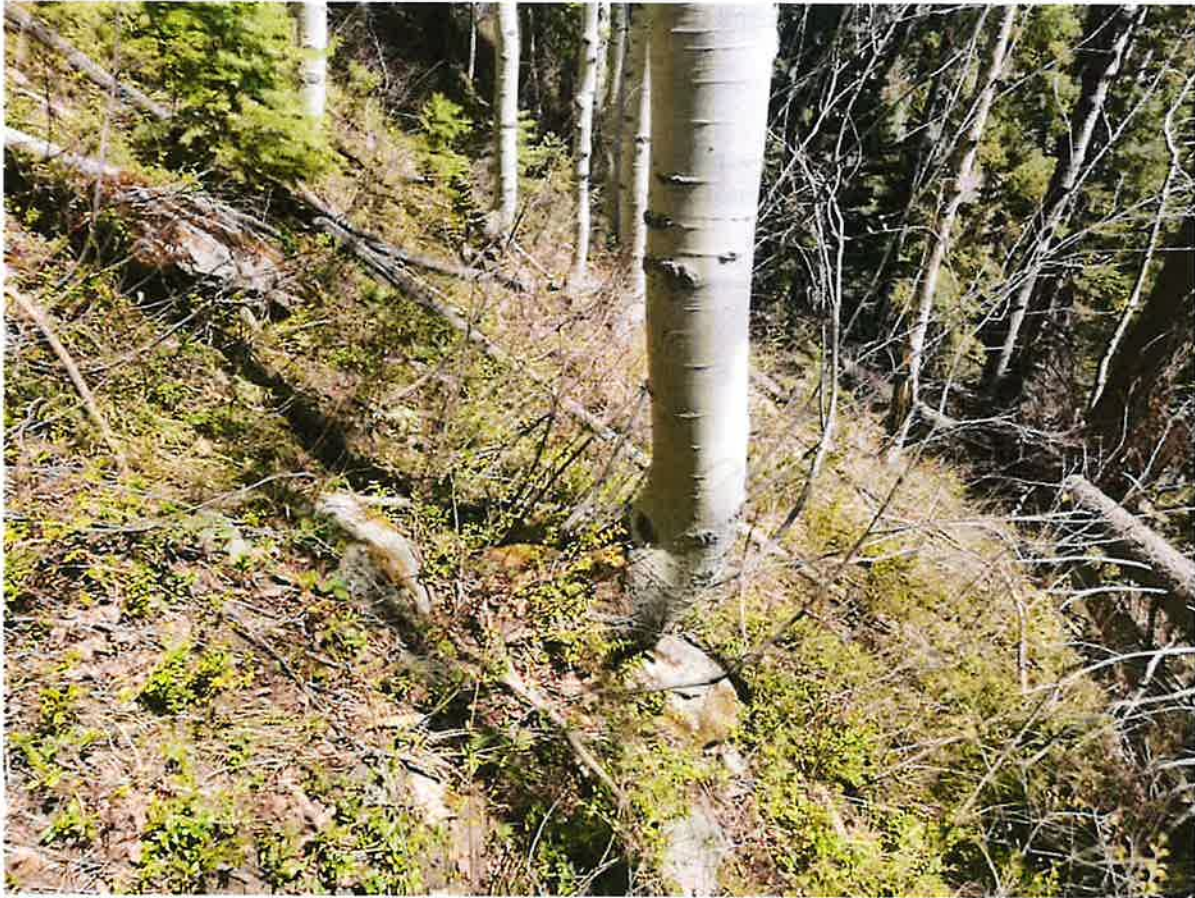
Photograph 2: Typical geotropism (aka tree pistol-butting) along slopes above the site.

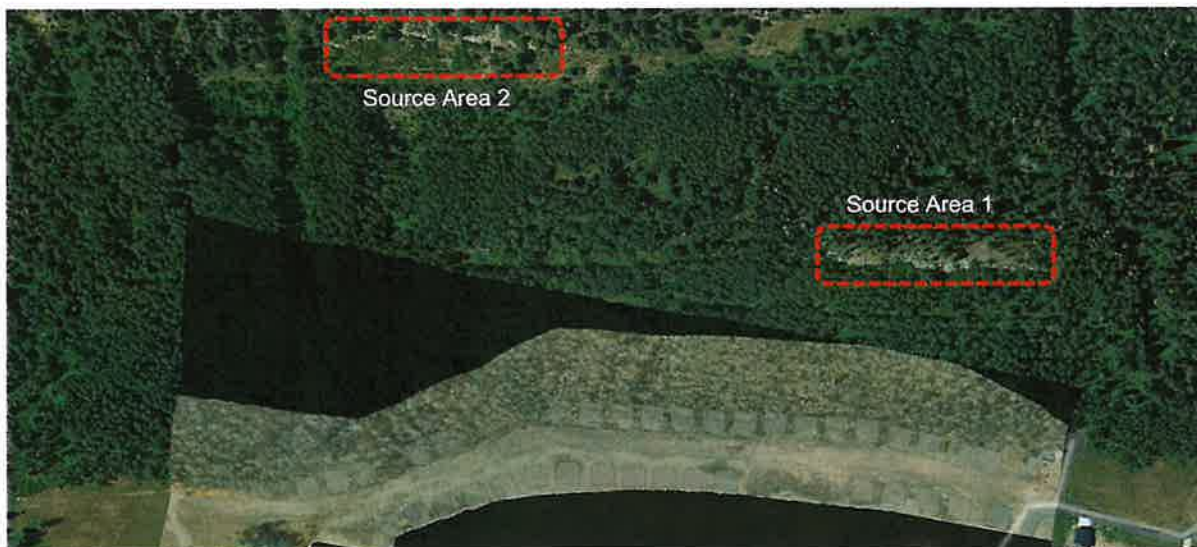
Figure 3.2: Location of Rockfall Source Areas.

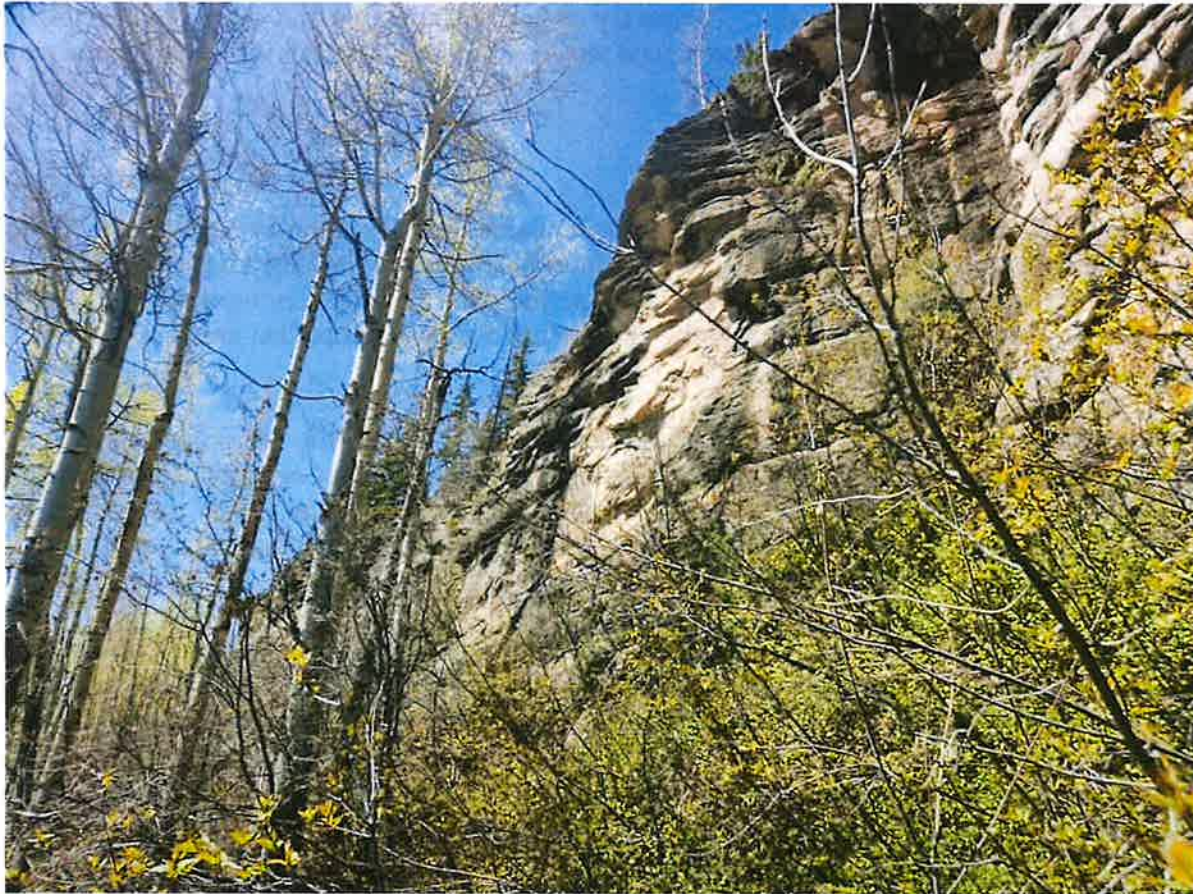
Photograph 1: View of Source Area 1.

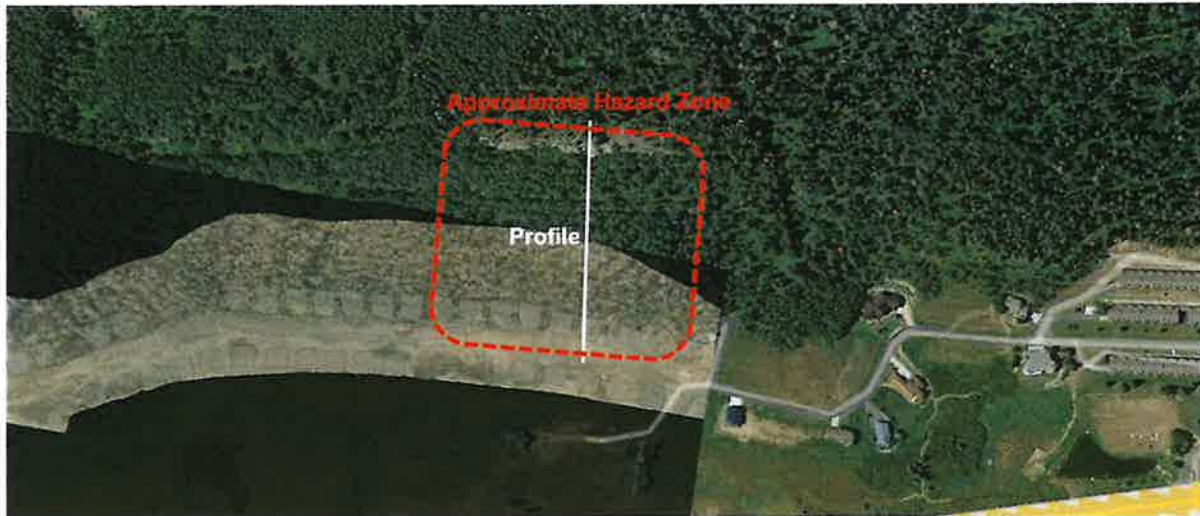
Figure 3.3: Approximate Location of Rockfall Analysis Profile and approximate hazard zone.

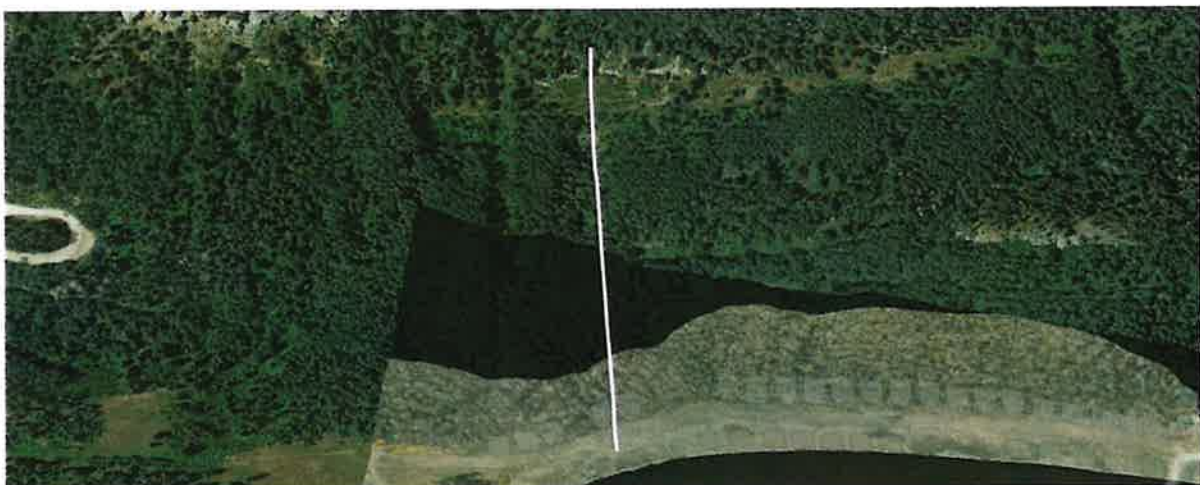
Figure 3.8: Approximate RocFall Analysis Profile.

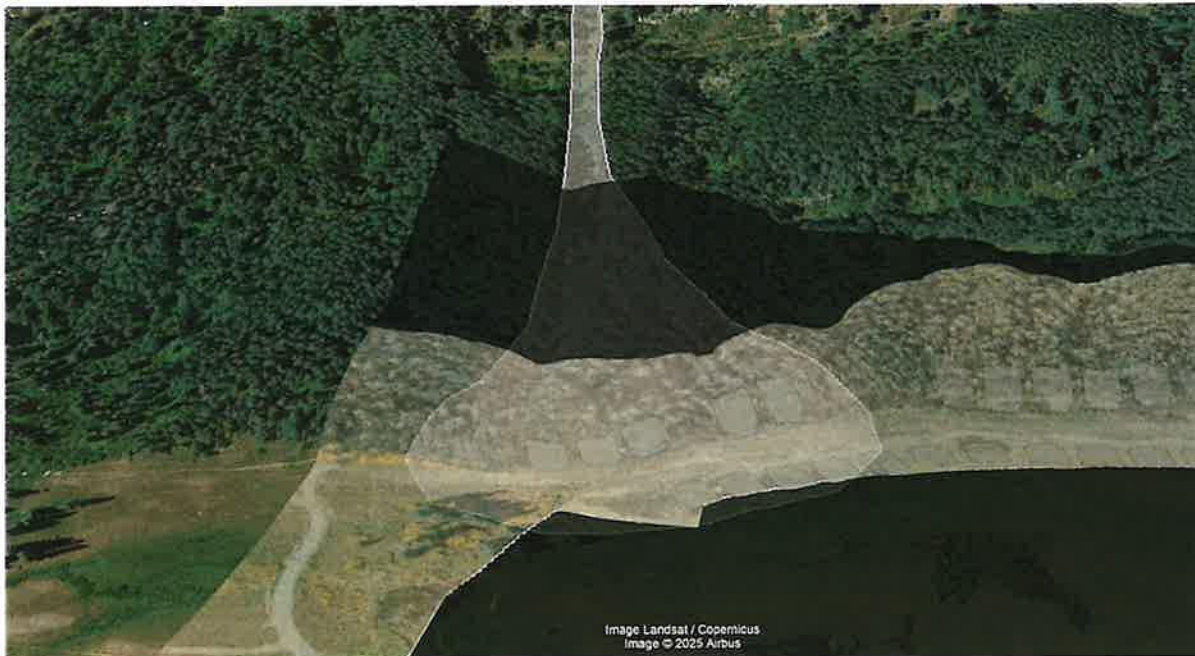
Figure 3.11: Debris flow and fan hazard area outlined on the site schematic.
