MEMORANDUM

Fr: William A. Tookey, Land Use Administrator

Re: Overland Estates Subdivision Preliminary Plan

PHASE I ENVIRONMENTAL SITE ASSESSMENT

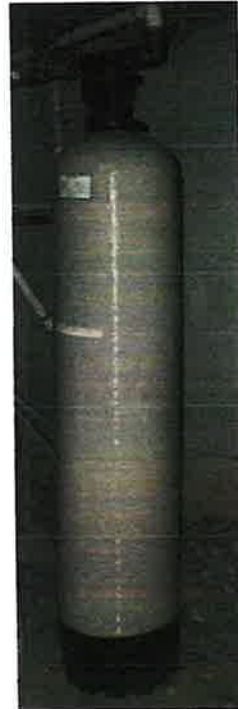
The upflow system has a simple in and out head. Note the fill port at the top of the head, allowing for the addition of replacement media.

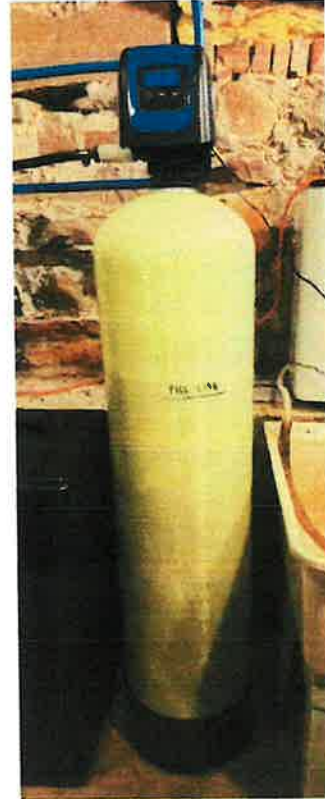
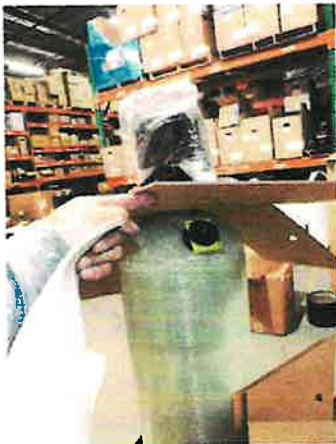
Both systems use a calcite media which slowly dissolves into the water as it raises pH. Hence the need to replenish it.

Note the fill line mark on the photo to the right. This provides an indicator. As the media drops it needs to be replenished.

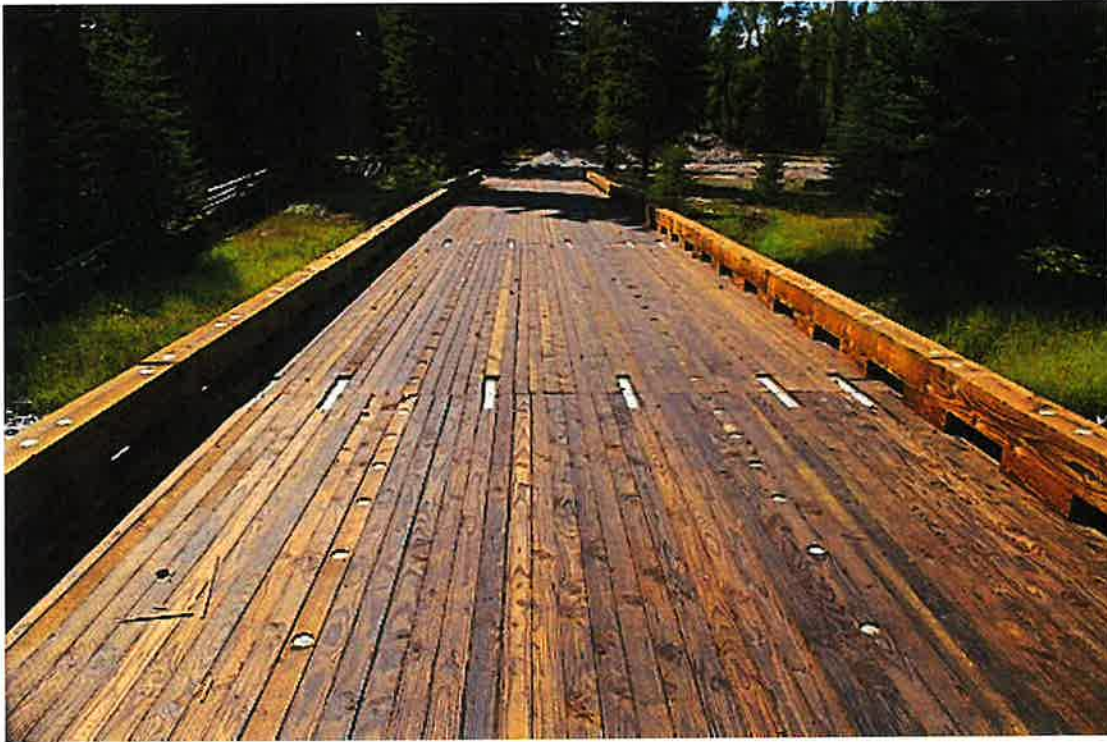
A few key points on this system:

- Design Meets HS 20-44 standards or 80,000 lb. 40 ton capacity.
- An optional drainage gravel will be utilized.
- Bridge may not exceed 2% slope
- 5' Overlap on land of bridge ends is mandatory and painted onto bridge sections.
- Owner will assist in yearly inspections of hardware and welds
- Tensioning of compression bolts must be checked every 10-15 years
- Owner has constructed much larger bridges in the wilderness prior.
- Bridge is well above the FEMA Flood Plane
- Troutner Geo Tech has tested the bearing soil and provided a letter in reference to this bridge installation.
