### SCENIC QUALITY REPORT ADDENDUM

Proposed Silver Cloud Lodge/PUD

Shelbyville Lode USMS No. 18168 et al Mill Creek near Chattanooga Highway 550, San Juan County, Colorado

Engineer Mountain, Inc. Attn: Lisa Adair PE 962 Reese Street PO Box 526 Silverton, Colorado 81433 (970) 387-0500 Job No. 2023-101

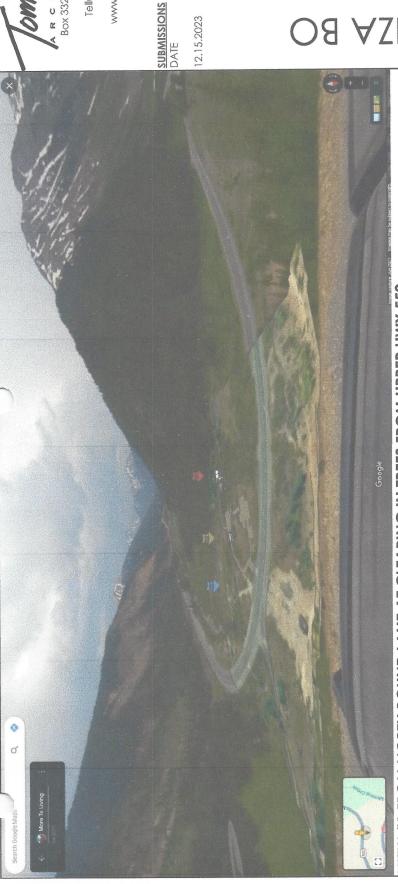
The following page is labelled "View #1." It was prepared by the project Architects to depict the anticipated view of the proposed garage/employee housing structure on the Bonanza Boy Mill Site, as viewed from far above the Chattanooga townsite, looking south from Highway 550. The anticipated view of the proposed centralized guest/employee parking areas (and some proposed grading/walkways) is also shown, as requested.

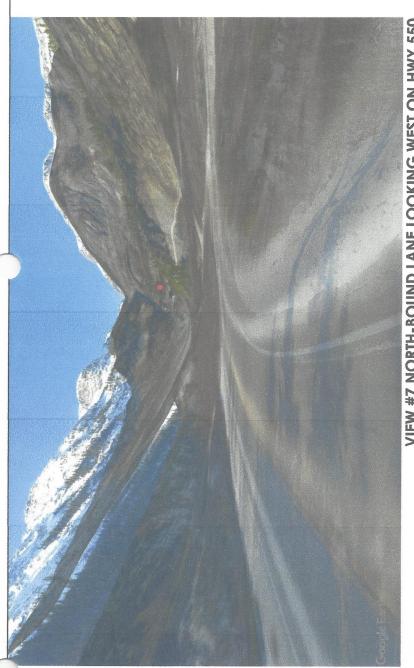
The following pages are labelled "View #7," "View #8," and "View #9." These visual aids were prepared by the project Architects to depict the anticipated view of the **proposed Lodge Structure in Mill Creek**, as viewed by a driver in a vehicle (at three different locations) from the tight, hairpin curve called Mule Shoe Curve on Highway 550. The proposed lodge structure is approximately 1/2 mile up the existing 4WD gravel 4WD road called Mill Creek Road (USFS Rd. 821/County Road 15).

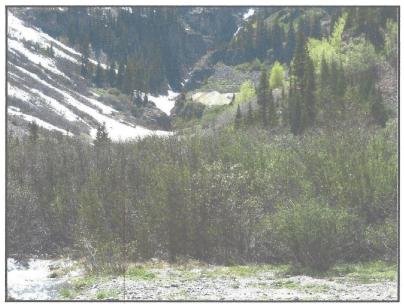
Figure 7. View of the site from the major bend on U.S. Highway 550 with Mill Creek to the right. View is to the west.

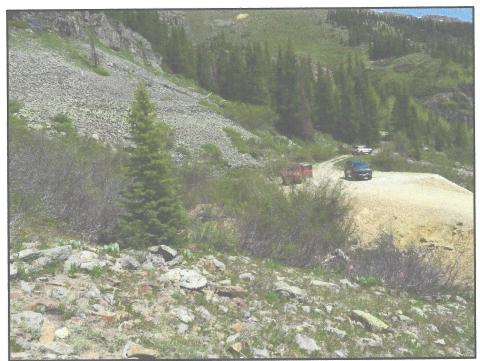
Figure 9. Looking north across the top of the waste rock with the A-shaped avalanche deflector on the slope to the left. The distant vehicle is on the upper portion of the road switchback.

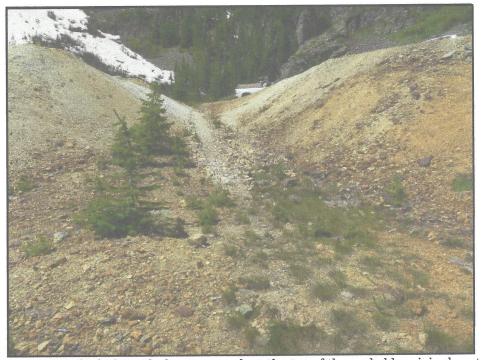
Figure 10. Cleft through the waste rock at the top of the probable original route to the mine, looking southwest.

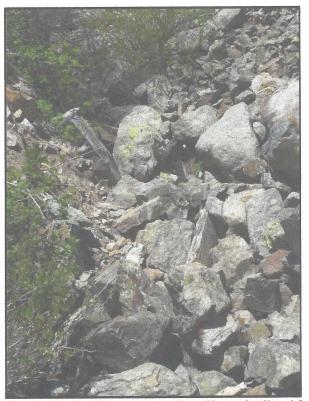
Figure 12. Looking west at the collapsed adit with post and plank framing debris.

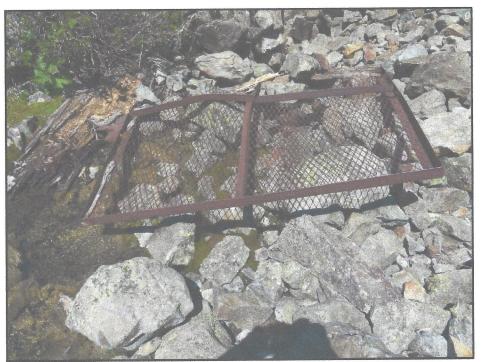
Figure 13. Exclusion gate disposed of below the adit. View is to the west.

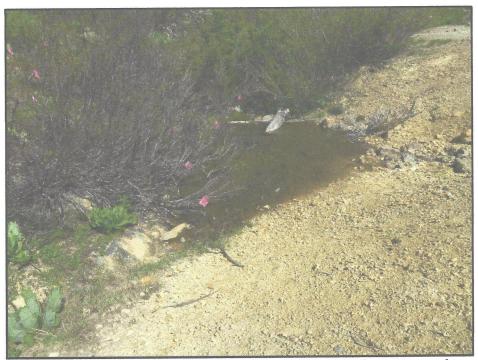
Figure 14. Water from the adit ending in a small pond at the upper southwestern edge of the waste rock. View is to the west.

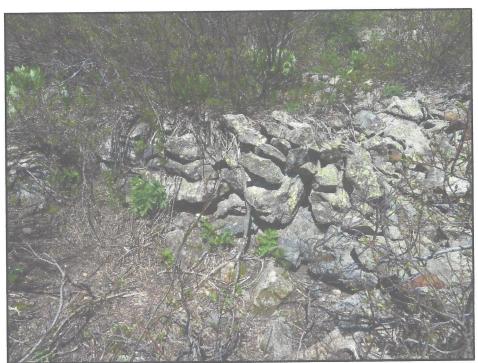
Figure 15. Looking west at the southernmost retaining wall.

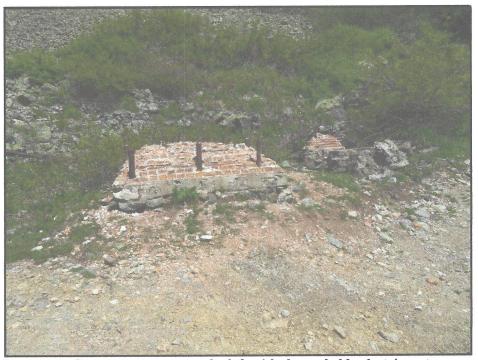
Figure 18. Compressor mount to the left with the probable electric motor mount to the right, looking north-northwest.

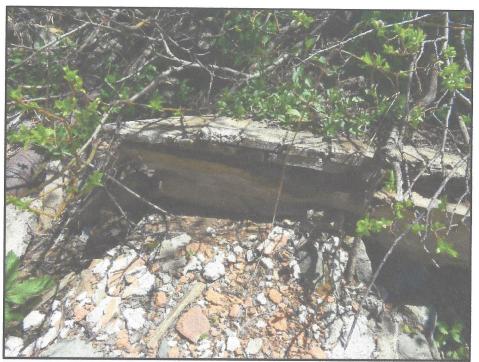
Figure 21. Building floor remnant showing diagonal 1-x-6-in. subfloor topped by 1-x 4-in. tongue and groove flooring set on 3-x-6-in. joist. View is to the north.

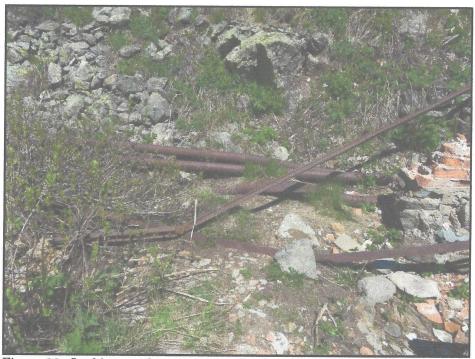
Figure 22. Looking northwest at 4-in.-diameter iron compressed air pipe and ore car rail adjacent to the compressor mount.

Adjacent and to the southwest of the machinery mounts are sections of ore car rail and 4-in.-diameter compressed air iron pipe (Figure 22). Sections of the pipe are connected with pipe couplers marked "4XXX/5TGR/VICT/AULIC" (Figure 23) According to the U.S. Patent Office, the Victaulic trademark was first used in 1920 for pipes and pipe fittings. It is a live trademark last renewed in 2015 by the Victaulic Company of America, Easton, Pennsylvania. It is likely that the pipe and rail represents the last period of mining at the site in the late 1940s. Other artifacts found in the area include window glass fragments, wire nails, a cast-iron stove top marked "No. 30" with an oval stove pipe opening, rotary-opened sanitary food cans, galvanized sheet metal, rolled galvanized sheet metal that has been soldered to form a pipe or nozzle, 2-in.-diamter iron pipe, white porcelain insulator fragments, and a light green rectangular bottle fragment.

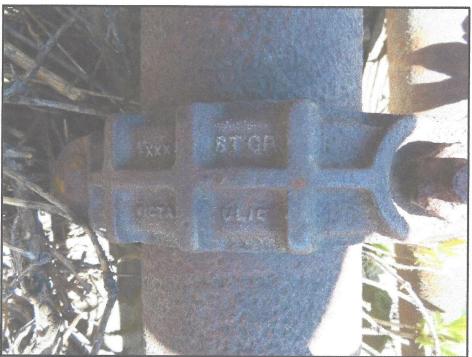
Figure 23. Victaulic pipe coupler on 4-in.-diameter iron compressed air pipe.

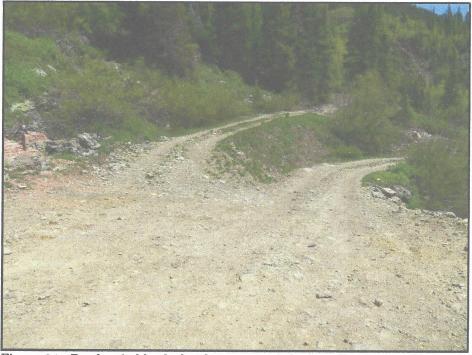
Figure 24. Road switchback that has removed the boarding house/office and pushed it and artifacts downslope. View is to the north.

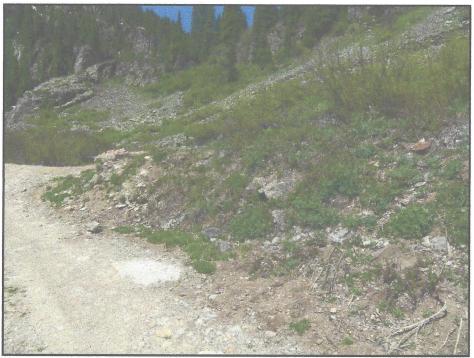
Figure 25. Looking southwest at the cut bank below the road switchback that contains heavily disturbed artifacts.

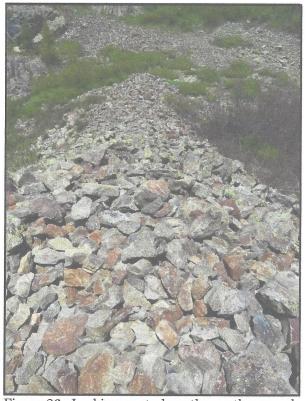
Figure 26. Looking west along the southern avalanche deflector wall.

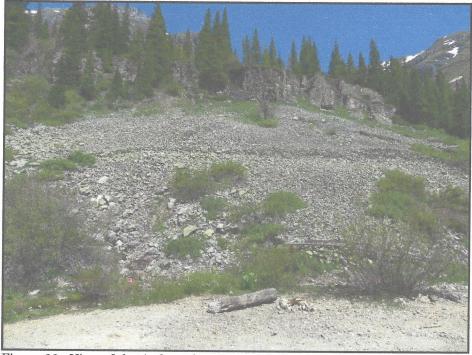
Figure 28. View of the A-shaped avalanche deflector walls on the rocky slope west of the mine. View is to the west.

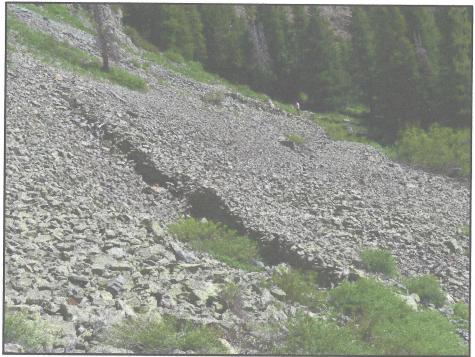
Figure 29. A-shaped avalanche deflector walls looking north-northeast from the southern avalanche deflector wall.

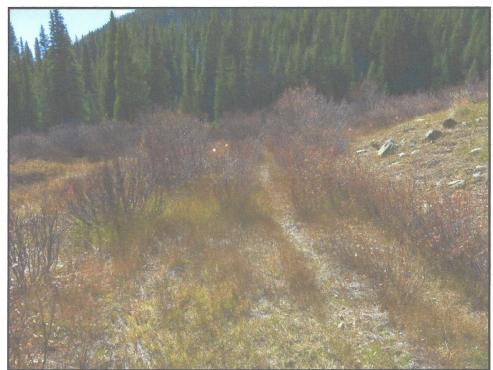
Figure 9. Southern end of the road section within the Bonanza Boy Mill Site, looking southwest. Note willows and grasses growing up through roadbed.

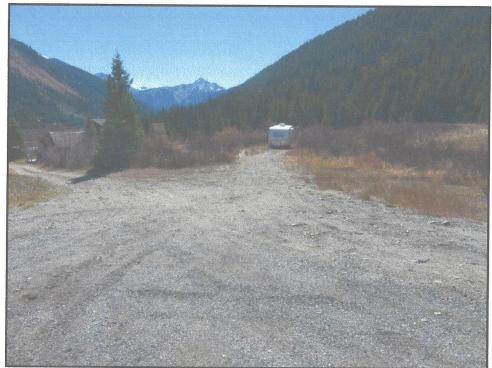
Figure 13. Looking south from US Highway 50 along the northern portion of the recorded road section. The trailer is on the road route and a driveway to the cabins is to the left.

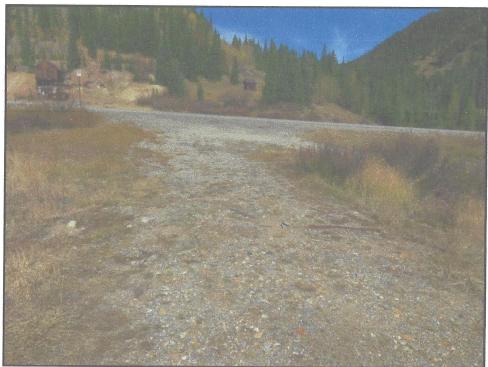
Figure 14. The northern end of the road segment in the Bonanza Boy Mill Site looking north toward US Highway 550 with the Silver Ledge Mill ore tipple across the highway to the left. The culvert is visible on the right side of the road.

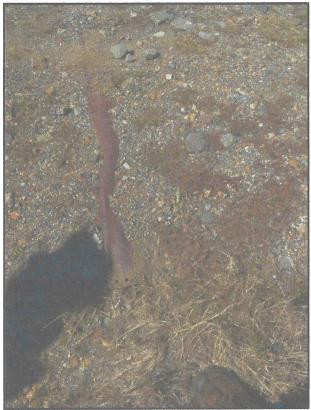
Figure 15. Riveted pipe culvert in the northern portion of the recorded road, looking northwest.

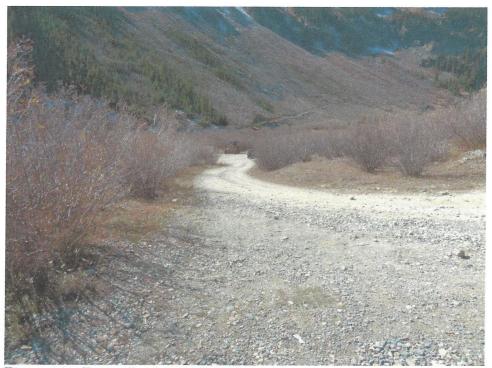
Figure 12. Forest Road 821 probably running an the historic alighment of the Silverton & Red Mountain Railroad, but has so altered it that it no longer clearly a railroad grade. View is to the southwest.

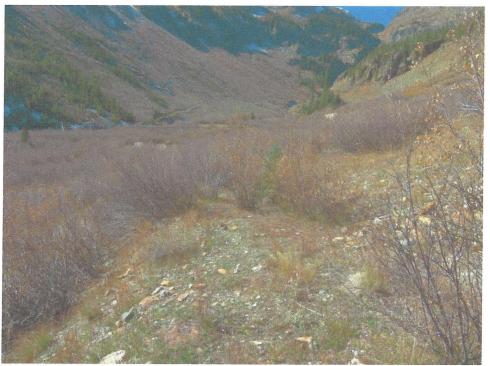
Figure 14. Looking southwest along the spur grade from the Happy Jim Mine (5SA112.15) as it disappears into the willows.

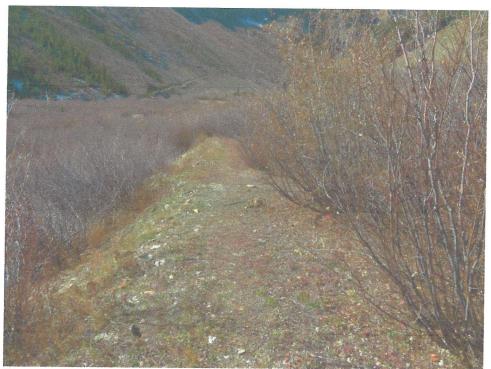
Figure 15. The main line grade (5SA112.16) partly covered with willows, looking southwest. Note the fill of the grade extending downslope to the left.

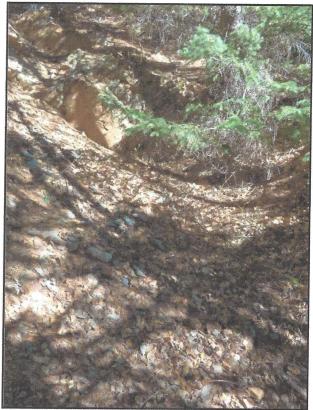
Figure 19. Looking north along the mostly filled adit trench of 5SA406 below the rock outcrop where the adit extended below ground.

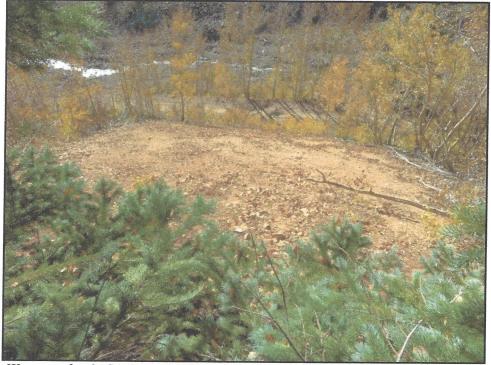
Figure 20. Waste rock of 5SA406 extending downslope to Forest Service Road 821 below the adit trench of 5SA406. View is to the south.

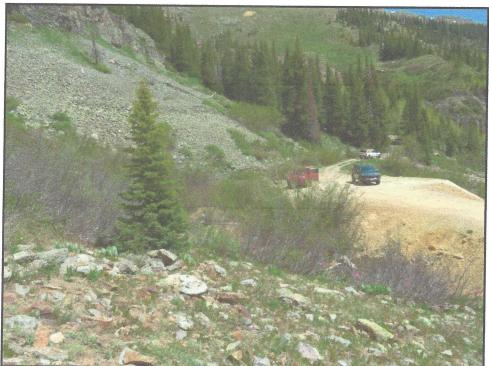
Figure 24. Looking north across the top of the waste rock of the Silver Crown Mine (5SA407) with the A-shaped avalanche deflector on the slope to the left. The distant vehicle is on the upper portion of the road switchback.

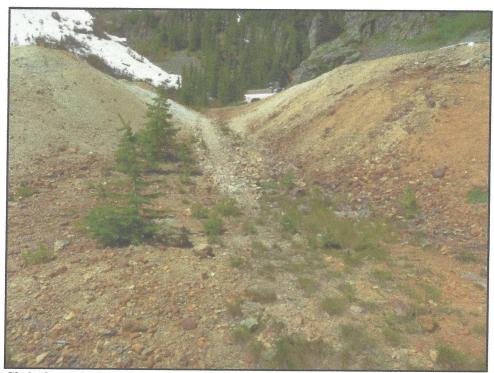
Figure 25. Cleft through the waste rock at the top of the probable original route to the Silver Crown Mine (5SA407), looking southwest.

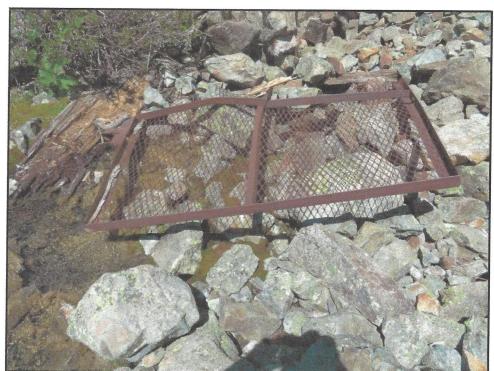
Figure 28. Exclusion gate disposed of below the adit of the Silver Crown Mine (5SA407). View is to the west.

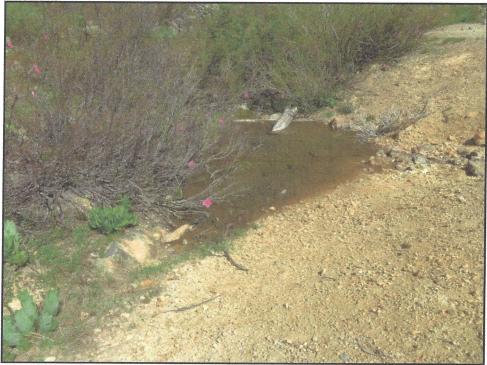
Figure 29. Water from the adit ending in a small pond at the upper southwestern edge of the waste rock of the Silver Crown Mine (5SA407). View is to the west.

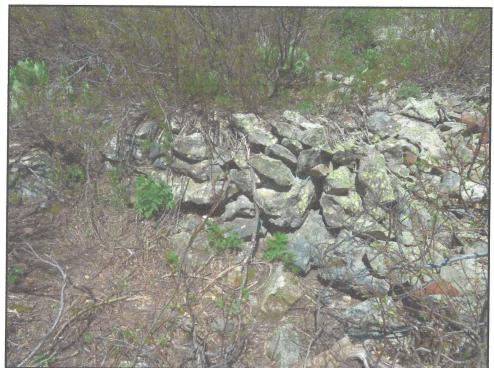
Figure 30. Looking west at the southernmost retaining wall at the Silver Crown Mine (5SA407).

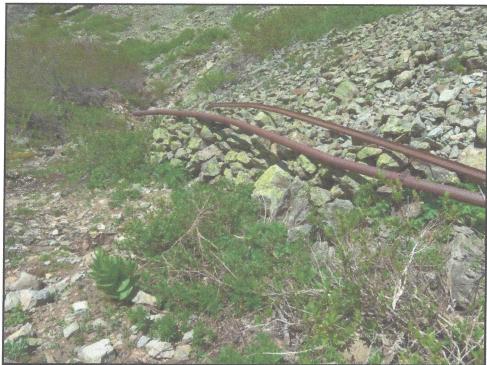
Figure 31. Looking west at the central retaining wall remnant with ore car rail and compressed air pipe disposed on it at the Silver Crown Mine (5SA407).

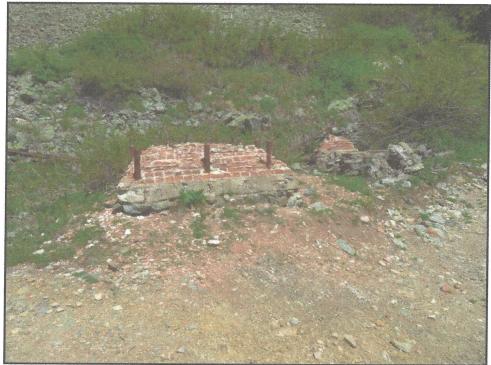
Figure 33. Compressor mount to the left with the probable electric motor mount to the right at the Silver Crown Mine (5SA407), looking north-northwest.

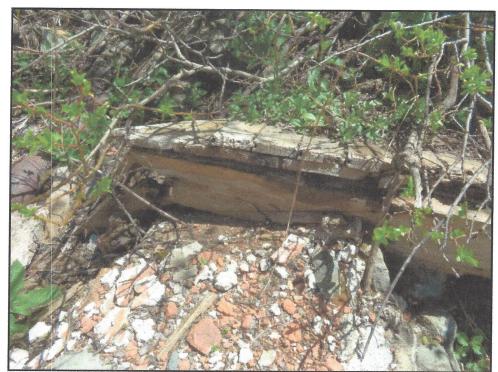
Figure 36. Building floor remnant showing diagonal 1-x-6-in. subfloor topped by 1-x 4-in. tongue and groove flooring set on 3-x-6-in. joist at the Silver Crown Mine (5SA407). View is to the north.

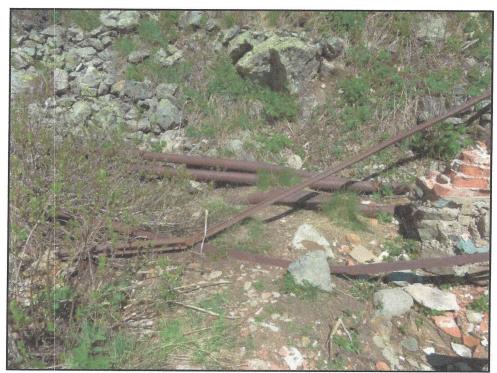
Figure 37. Looking northwest at 4-in.-diameter iron compressed air pipe and ore car rail adjacent to the compressor mount at the Silver Crown Mine (5SA407).

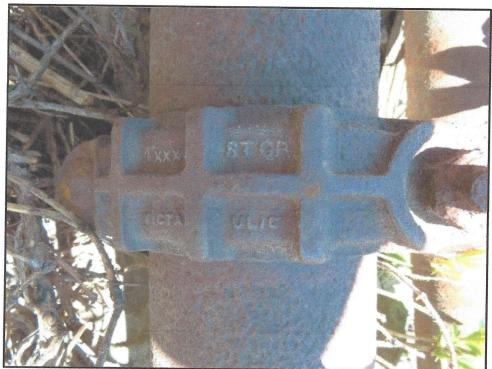
Figure 38. Victaulic pipe coupler on 4-in.-diameter iron compressed air pipe at the Silver Crown Mine (5SA407).

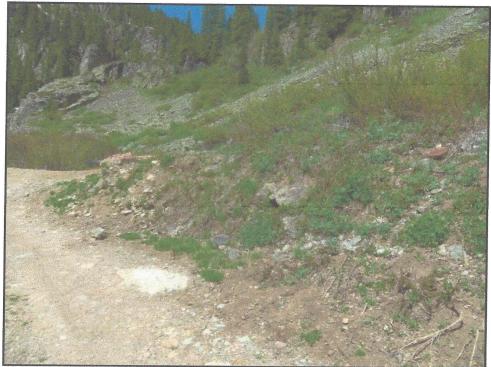
Figure 40. Looking southwest at the cut bank below the road switchback that contains heavily disturbed artifacts at the Silver Crown Mine (5SA407).

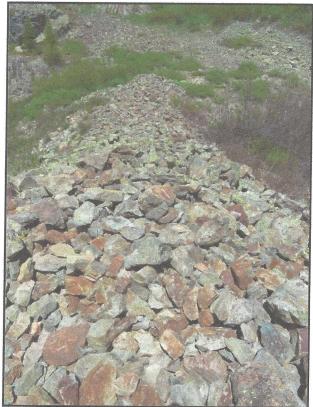
Figure 41. Looking west along the southern avalanche deflector wall at the Silver Crown Mine (5SA407).

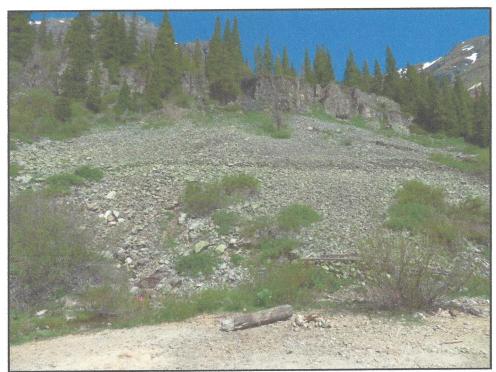
Figure 43. View of the A-shaped avalanche deflector walls on the rocky slope west of the Silver Crown Mine (5SA407). View is to the west.

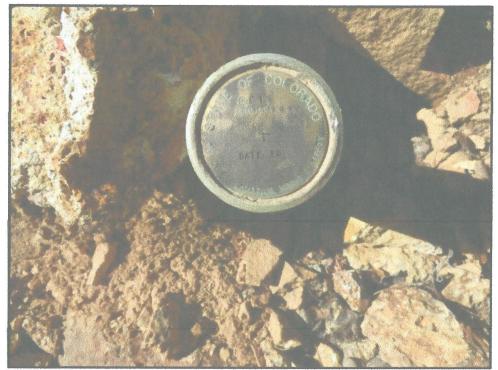
Figure 50. Looking west at the brass cap on end of pipe in cobble and soil fill of the adit of 5SA468.

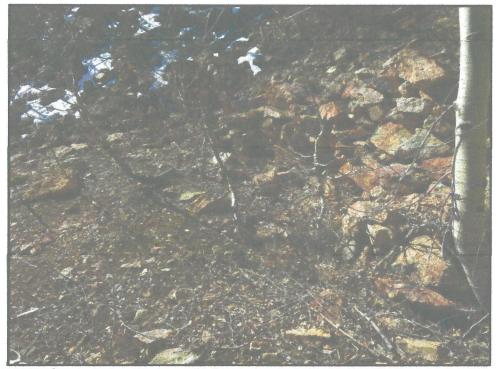
Figure 51. Looking southwest across the leveled area of 5SA469 with an uncoursed native stone wall to the left.

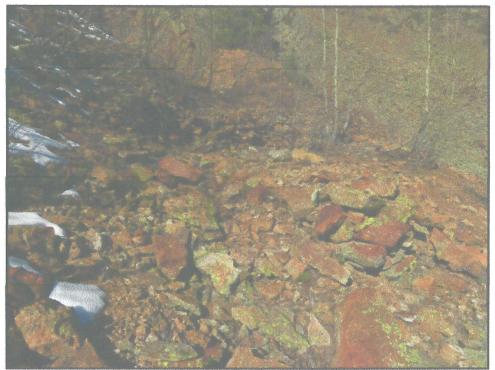
Figure 52. Small leveled platform at site 5SA468 with rock wall above and remnant of rock wall on lower edge to the right. View is to the north-northwest.

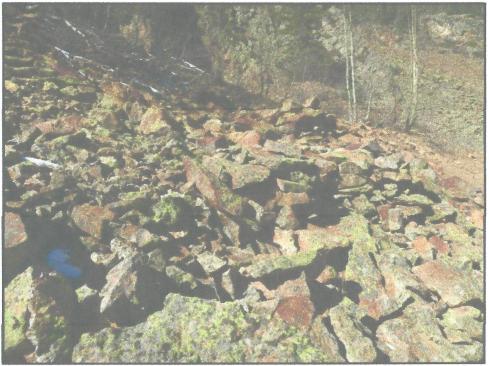
Figure 53. Lower rock wall at site 5SA468 holding back large pieces of waste rock with other walls of platform above, looking northwest.

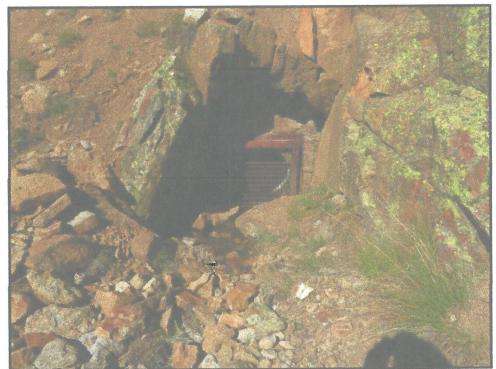
Figure 56. Adit of site 5SA1875 covered by a steel gate set in wet-laid stone masonry. View is to the northwest.

Site 5SA1875 is a small mine exploration adit at the base of a bedrock outcrop on a steep talus slope on private land above and immediately north-northwest of Forest Service Road 821 at an elevation of 10,640 ft. (Figure 55 to Figure 58) The site is on the Milwaukee Lode, part of MS 18179. The site consists of a 4-ft.-wide, 5-ft.-tall adit dug northwest into bedrock covered by a 3-by-3-ft. welded steel gate set in wet-laid stone masonry with a 3-ft.-diameter corrugated culvert in the adit behind the gate to allow water to drain from the adit. A brass cap has mounted on the gate that reads "MINED LAND RECLAMATION DIVISION OF STATE OF COLORADO/PROJECT 08 20 2."

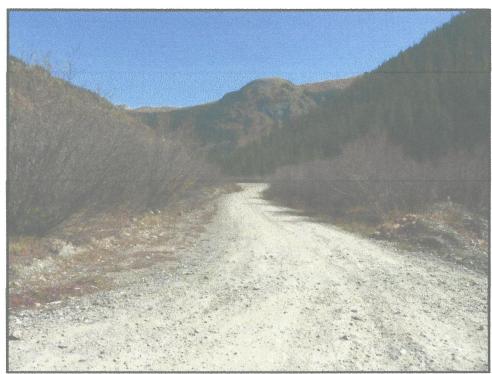
Figure 61. The northeastern end of Forest Service Road 821 (5SA1876.1) to its intersection with US Highway 550. View is to the north-northeast.

shorter distance, which explains the greater number of switchbacks in that section. Forest Service Road 821 (5SA1876.1) begins as a 16-ft.-wide graded dirt and gravel road that heads west from Highway 550 for 400 ft. to a major curve that has been widened through use for parking and staging of equipment and turns sharply north-northeast for another 160 ft. where the Silverton & Red Mountain Railroad grade intersects it heading northeastward (Figure 61 to Figure 63). It then turns sharply westward and narrows to 12 ft. wide on a cut-and-fill grade that climbs gradually following the contours of a steep southeast-facing slope onto the northern portion of the flattened top of the waste rock pile of the Silver Crown Mine (5SA407) (Figure 64 to Figure 69). The road turns sharply northeastward on the waste rock and heads more steeply upslope as a 10-ft.-wide graded two-track dirt and rock road through two more switchbacks to the end of the recorded section of the road (Figure 70). The remainder of the road to the Silver Cloud Mine is depicted on the USGS map of the area and is visible on aerial photos.

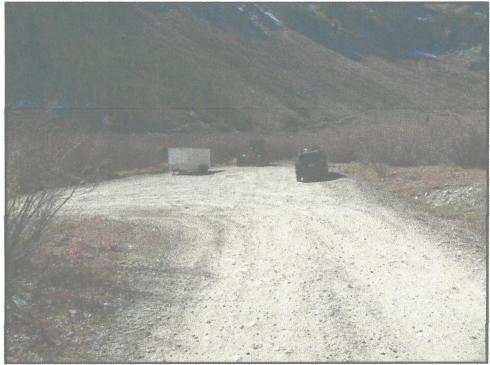
Figure 62. Looking southwest at the curve of Forest Service Road 821 (5SA1876.1) above US Highway 550 used for parking and staging equipment, vehicles, and campers.

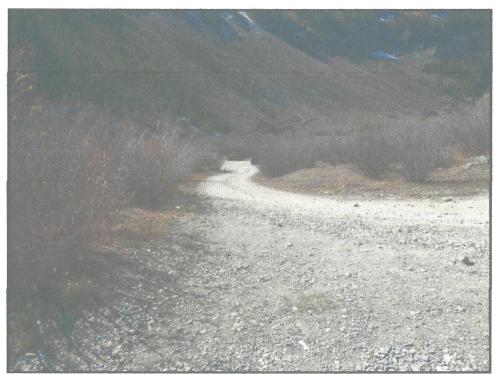
Figure 63. Forest Service Road 821 (5SA1876.1) from the intersection with the main grade of the Silverton & Red Mountain Railroad, looking southwest.

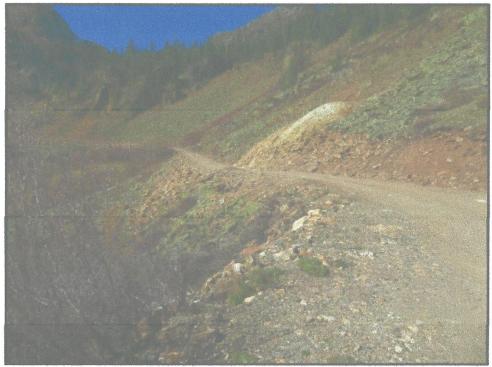
Figure 64. Cut and fill construction of Forest Serivce Road 821 (5SA1876.1) with the waste rock of site 5SA1875 visible near the center extending to the road. View is to the west.

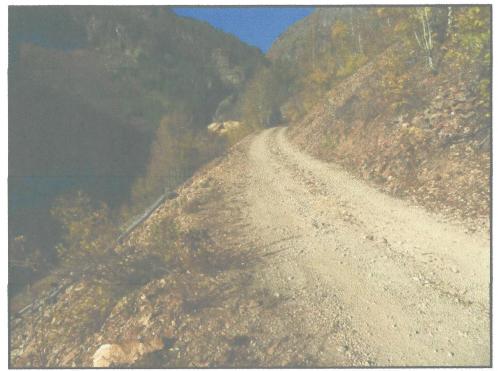
Figure 67. Cut and fill construction of Forest Service Road 821 (5SA1876.1) with the Silver Crown Mine (5SA407) in the distance. View is to the west.

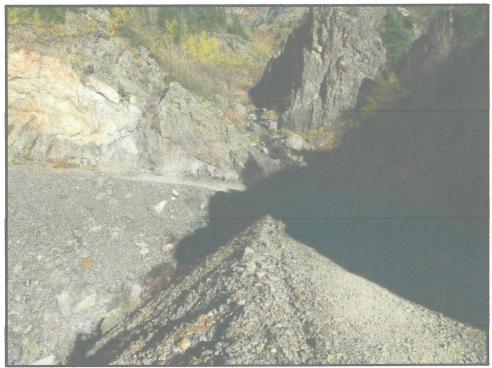
Figure 68. Looking north along Forest Service Road 821 (5SA1876.1) toward the crossing of a small stream.

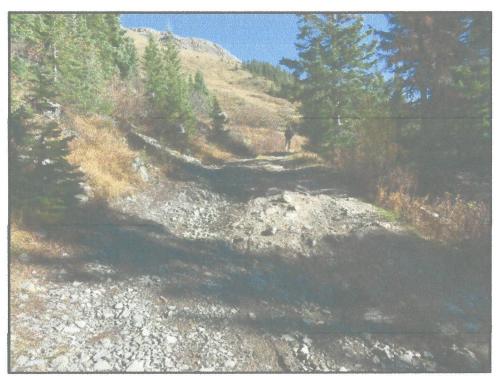
Figure 70. Forest Service Road 821 (5SA1876.1) above the Silver Crown Mine (5SA407) at the end of the recorded segment. Note the rough, eroded condition of the road with a slightly narrower width. View is to the east-northeast.

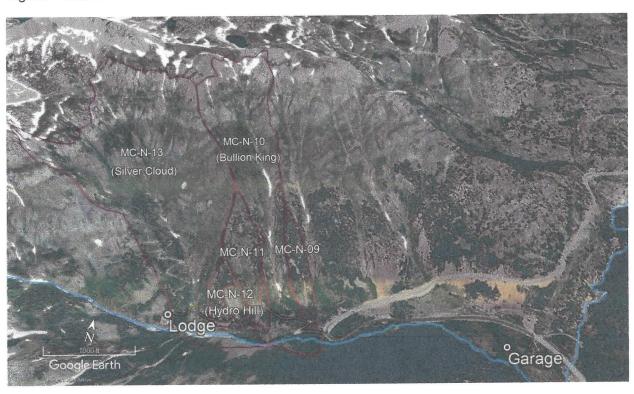
**Figure 5.** Avalanche terrain on the north side of Mill Creek affecting FSR 821. MC-N-10 (Bullion King) and MC-N-13 (Silver Cloud) frequently produce large destructive avalanches which reach the access road. The other three paths (MC-N-09, -11, and -12) are much smaller in scale.
