SAN JUAN REGIONAL PLANNING COMMISSION AGENDA

7:30 PM Cascade Meadows LLC

Subdivision Application for the Construction of up to 72 units on Tract A1

Traffic Impact Study – Draft Report Cascade Village

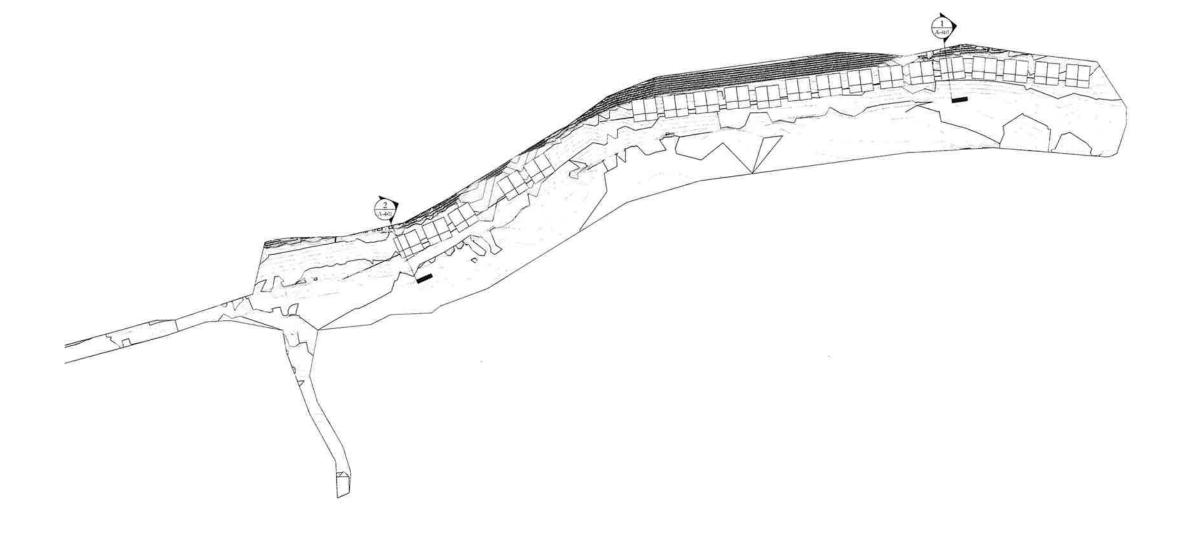
Site Plan

The design team and owner have analyzed topography, wetlands, soil conditions, traffic and overall market conditions. The site presents numerous challenges with the soil conditions of the wetlands, the steep slope to the west. The proposed package will reduce overall density with a simpler layout of townhomes. The townhomes will line Meadowview Drive. Most of the units will be built on the west side of the road and into the hillside. The others will line the wetlands where the impact is minimal.

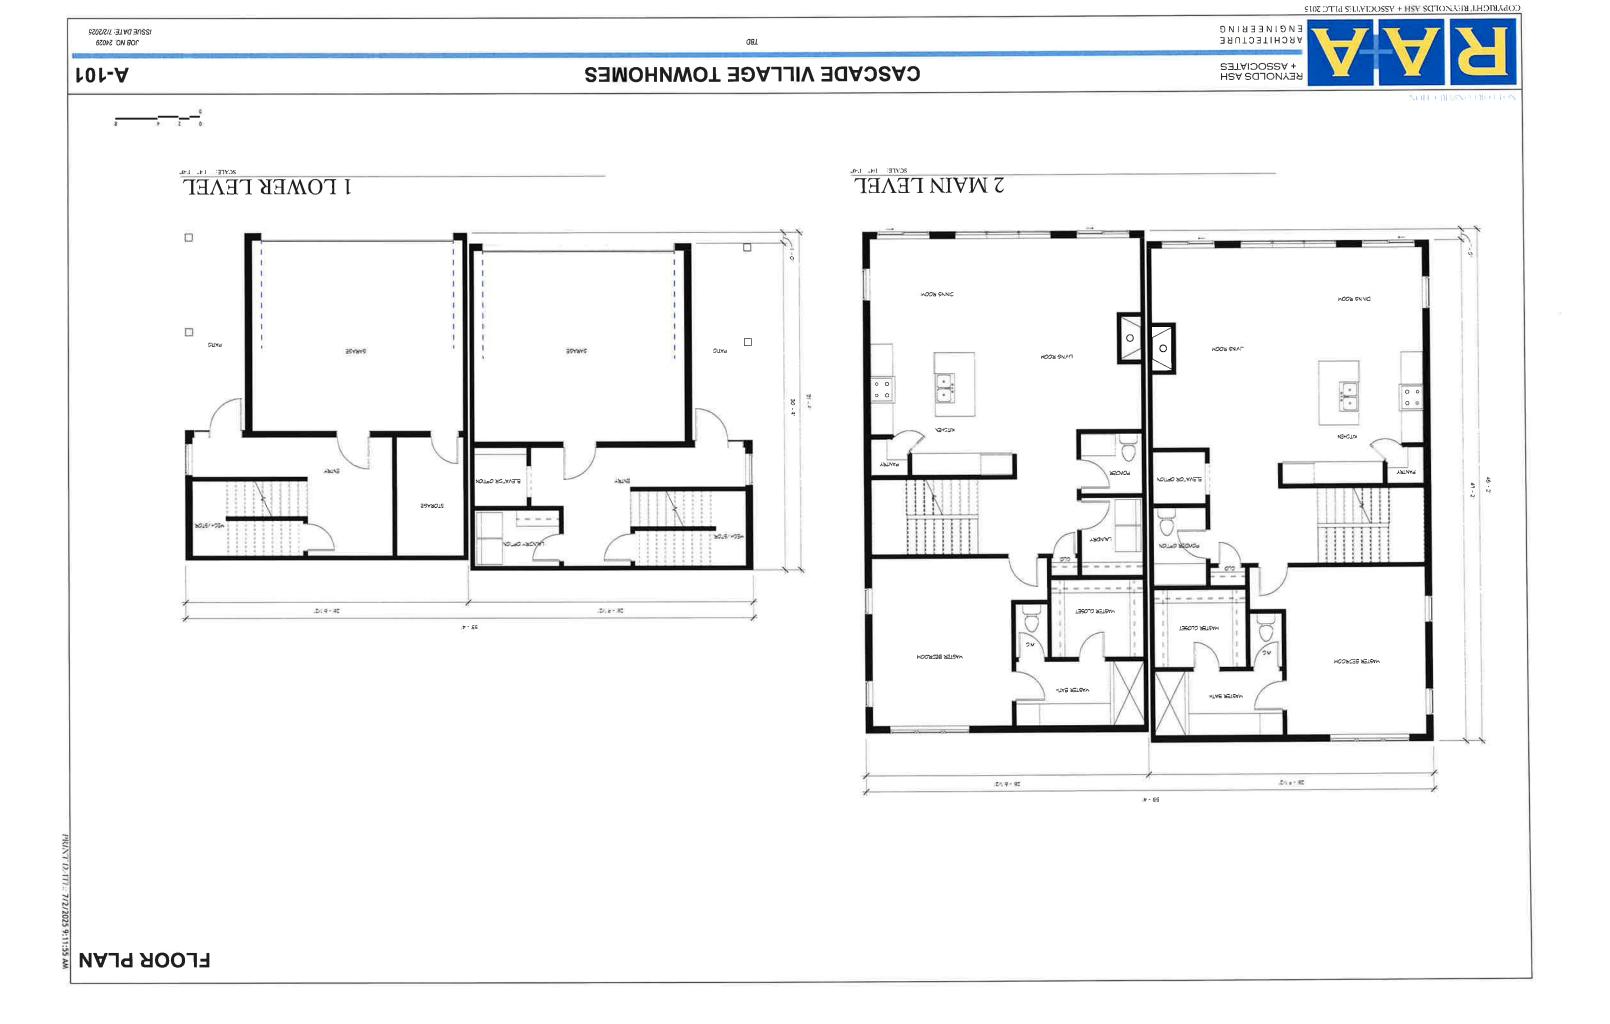
FLOOR PLAN

The proposed products will be three story townhomes. The design takes advantage of views across the highway and to the mountains on the east. The scale will be similar to the existing townhomes constructed across from Purgatory Resort. Each townhome is approximately 2,000 square feet with a garage and small driveway in front of the unit. The building envelope will include a mix of metal and wood siding. Overhangs, covered decks and awnings will add interest and protection to the buildings. The rooflines will be broken up to help with snow removal, but also to add interest to the envelope.

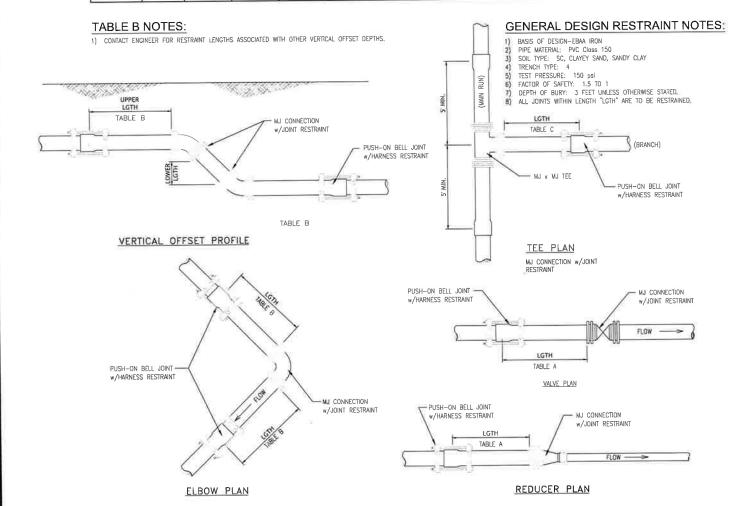
MECHANICAL JOINT RESTRAINT DETAIL

NOT TO SCALE

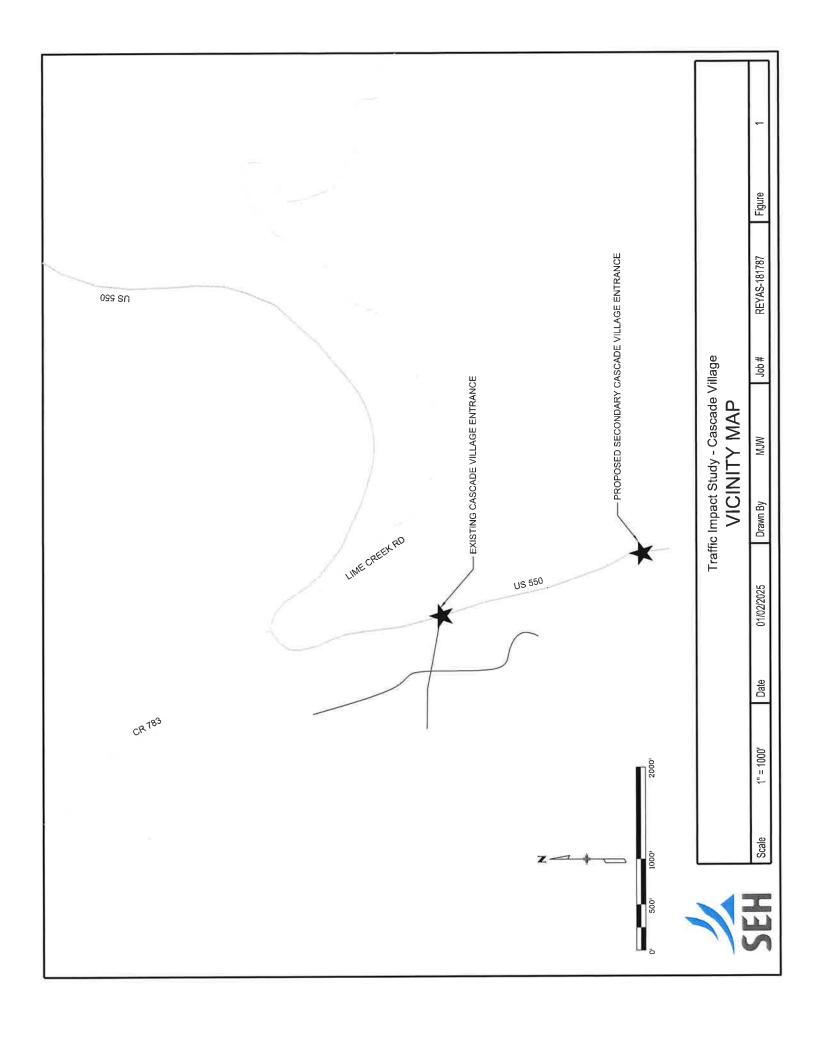
The purpose of this study is to identify traffic impacts and recommend mitigation measures associated with the proposed development of the site. This study examines intersection operations for existing, short-term (Year 2026), and long-term (Year 2046) traffic conditions. Typical weekday morning and evening peak periods were analyzed for site-specific impacts. A vicinity map showing the site location in relation to the surrounding roadway network is provided in **Figure 1**.

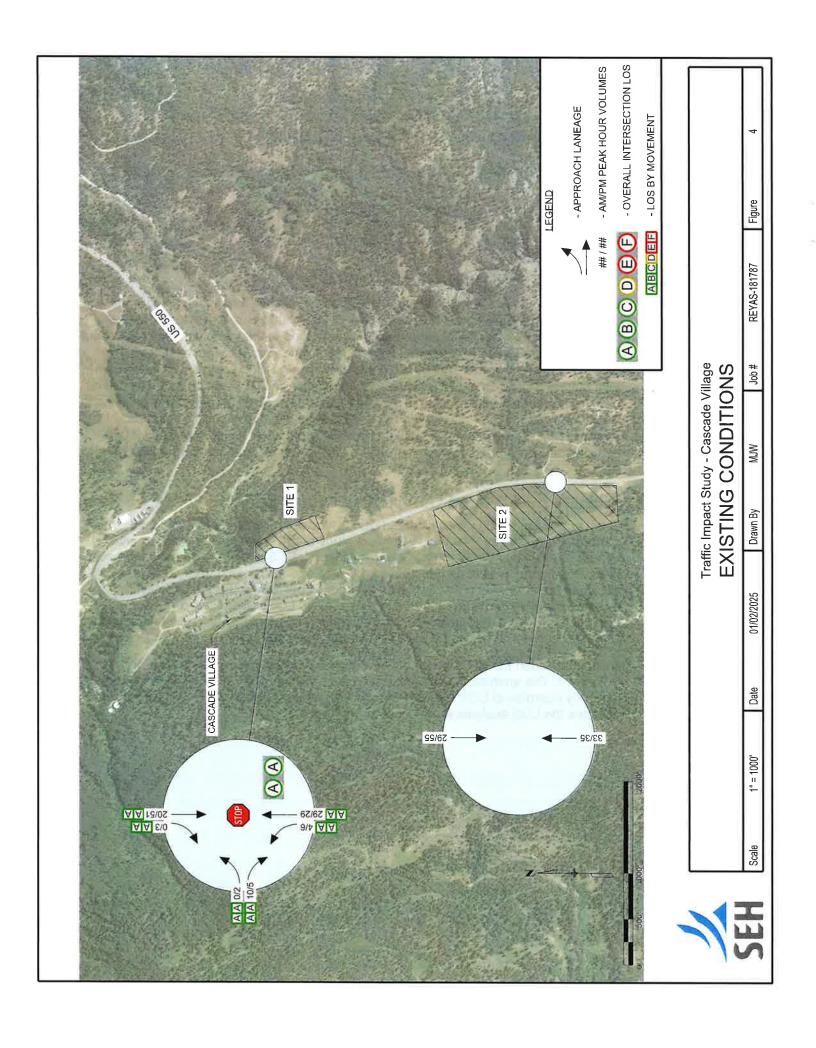
Figure 4 - Existing Conditions

Existing traffic counts were collected by SEH at the existing intersection at US 550 and Cascade Village on Wednesday, December 4, 2024 during the morning and evening peak hours. A seasonal adjustment factor was applied to the traffic volumes to account for the lower traffic observed during time of year traffic volumes were collected. The nearest continuous count station to the site is Station 104809 along US 160 between mile marker 83 and 84 in Durango. A seasonal factor of 1.07 was calculated for the month of December and applied to the collected traffic counts. **Appendix A** contains the turning movement count data and **Figure 4** displays the existing traffic volumes. Average Daily Traffic (ADT) for US 550 near the project site is approximately 2,000 vehicles per day (vpd) displayed in CDOT's Online Transportation Information System (OTIS).

Level of Service (LOS) was calculated using Synchro 11 software to evaluate the performance of the intersections within the study area. This software package utilizes criteria described in the <u>Highway Capacity Manual</u>¹. LOS is a measure used to describe operational conditions at an intersection. LOS categories ranging from A to F are assigned based on the predicted delay in seconds per vehicle for the intersection overall, as well as for individual turning movements. LOS A indicates very good operations, while LOS F indicates poor, congested operations. Overall intersection LOS D is considered acceptable by CDOT and most municipalities.

A summarization of the results of the intersection LOS calculations is displayed in **Table 1**. The analysis indicates that the intersection at US 550 / Cascade Village currently operates at LOS A with all movements also operating at LOS A. **Appendix B** contains the LOS analysis worksheets for reference.

Figure 4 – Existing Conditions (In Report)

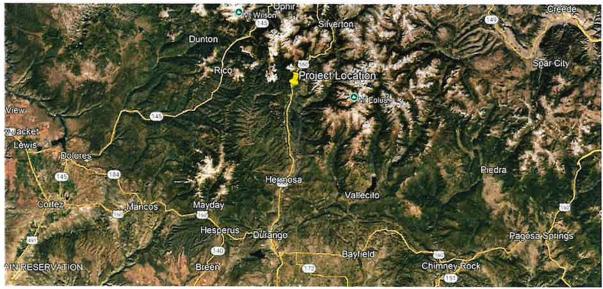
Figure 1.1: Site Location Schematic. Adapted from Google Earth (Image Date 12/31/2020).

Purgatory Resort in San Juan County, Colorado. The approximate coordinates of the site are 37.647462°, -107.809476°. The site location is shown on Figure 1.1 below.

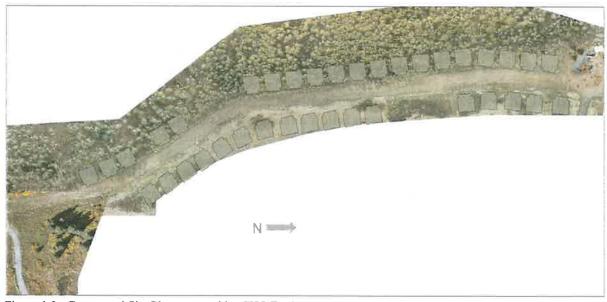
Figure 1.2: Conceptual Site Plan prepared by CHC Engineers, LLC.

We understand conceptual plans include 33 to 37 residential townhomes on the site. A conceptual schematic prepared by CHC Engineers, LLC is provided below as Figure 1.2.

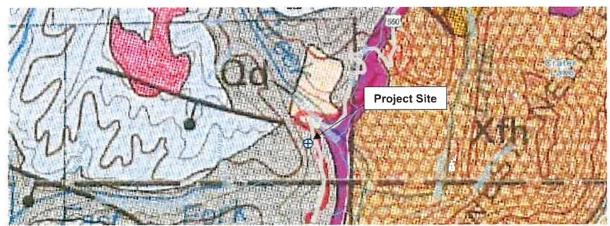
Figure 2.1: Steven, T.A., Lipman, P.W., Hail, W.J., Barker, Fred, and Luedke, R.G. Geologic map of the Durango quadrangle, southwestern Colorado. United States Geological Survey, Miscellaneous Investigations Series Map I-764, 1974. Map Scale 1:250,000.

Geologic units in the area consists of Precambrian metasedimentary and igneous units as well as Paleozoic and Mesozoic sedimentary layers of sandstone, limestone, shale and conglomerate. The sedimentary units exposed in the area include the Permian Cutler Formation (Pc), the Permian-Pennsylvanian Hermosa/Rico/Molas Formations undifferentiated (PIPrm) and the Mississippian-Cambrian Leadville Limestone/Ouray Limestone/Elbert Formation/Ignacio Formation undifferentiated (MCli*). These units are generally south dipping and cliff forming. Precambrian Irving Formation (pCi), Twilight Gneiss/Schist (pCtw) and Electra Lake Gabbro (pCel) outcrop east of the site in the West Needle Mountains and along the Animas River. Tertiary volcanics cap the mountains to the north and west of the site. Rock units in the area are often overlain by Quaternary sediments from glacial, fluvial, eolian, mass wasting and colluvial processes that continue to shape the landscape. Quaternary surficial deposits in the site vicinity are mapped as Glacial Drift (Qd) and Alluvium (Qa). A vicinity geologic map is presented in Figure 3.

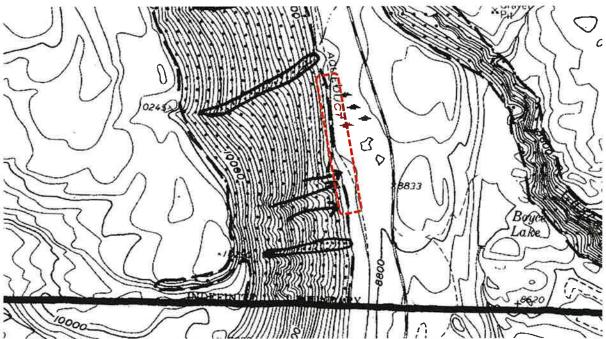
Figure 3.1: San Juan County Avalanche Hazard Instaar, Engineer Mountain, Colorado, U.S. Geological Survey, June 2, 1976. Arrows represent avalanche pathways. Approximate project area outlined in red.

Basic avalanche hazard mapping is available from San Juan County and is provided below showing the approximate project extents in red.

Based on review of the available mapping there is a potential avalanche path on the south end of the site that may affect some of the southern units. This is consistent with our field observations. We did not observe any recent evidence of large-scale avalanche activity; however, the central drainage feature in this area has relatively sparce tree cover which could be the result of periodic avalanche activity. A photograph of this feature from N. US Highway 550 is provided below.

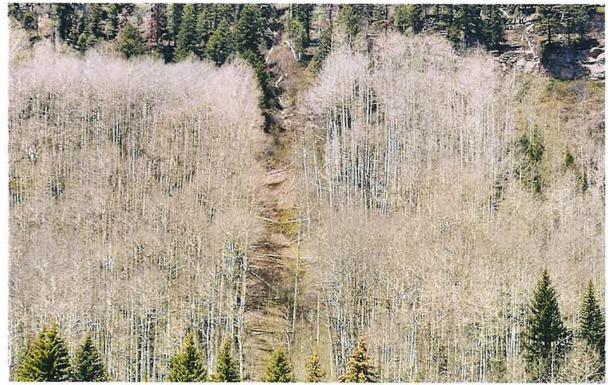
Photograph 1: View of potential avalanche slide path at south end of site looking west from N. US Highway 550.

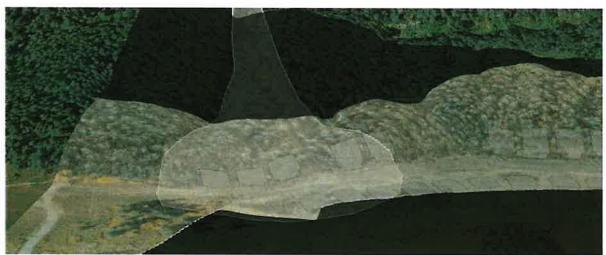
Figure 3.2: Conceptuel avalanche hazard zone schematic. Limits of avalanche area should be considered approximately and for general reference purposes only.

Based on our review of available mapping and our site reconnaissance, a conceptual hazard zone may result in impacts to the southern 8 to 10 proposed townhome units as shown below.

The schematic above should be considered approximate and is not suitable for design purposes. This schematic should only be used for conceptual planning purposes. We do not provide detailed avalanche hazard mapping including deposition depths, velocities and runout zones. If the owner is concerned about avalanche risk at the project site and is considering development at the southern

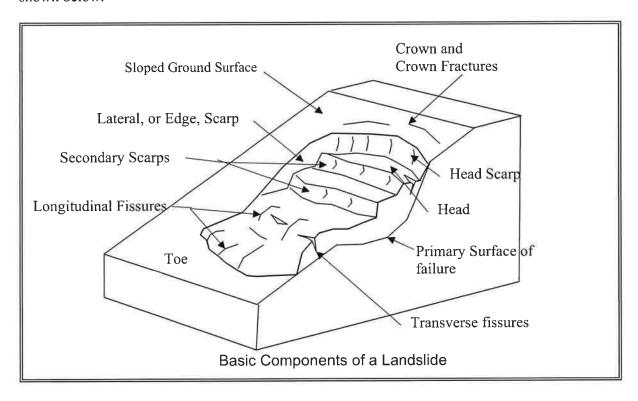
"Landslide" is a term to describe active slope movement. It is often used in a broad sense to describe any unstable slope or soil movement. A generalized depiction of a typical landslide is shown below.

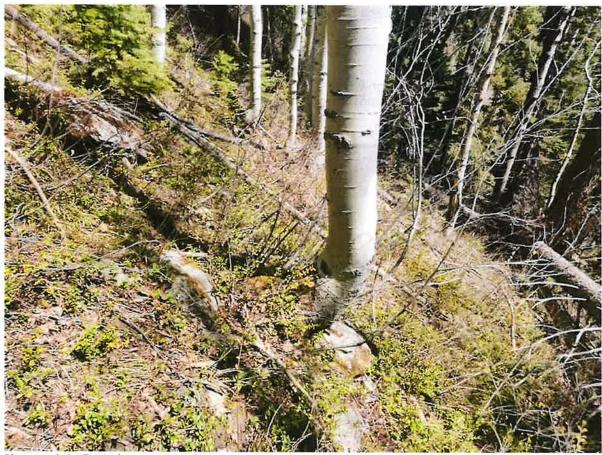
Photograph 2: Typical geotropism (aka tree pistol-butting) along slopes above the site.

We performed a site reconnaissance of the project area to identify potential mass movements within or adjacent to the project area. No evidence of large mass movement events in recent history were observed within the project area; however, we did observe suspected shallow surface creep evidenced by geotropism within trees throughout site slopes.

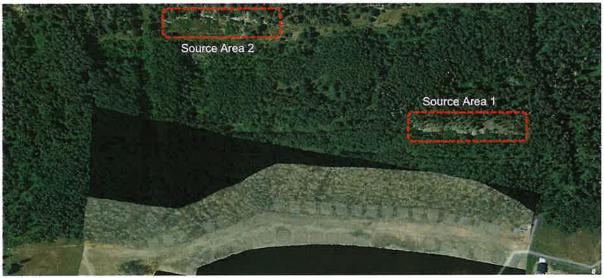
Figure 3.2: Location of Rockfall Source Areas.

Outcrops of the Hermosa Group sandstone and limestone above the site are potential source areas for rockfall hazard into the proposed development areas. Two main source areas were identified, one at the north end of the site and one at the south end of the site. The general source areas are identified below.

The southern source area (Source Area 2) is located nearly twice as high on the slope as Source Area 1 and is located above the southern portion of the of the project area as shown on Figure 3.2 above. The approximate analysis profile is shown in Figure 3.8 below. We have also provided our RocFall profile which is provided below as Figure 3.9.

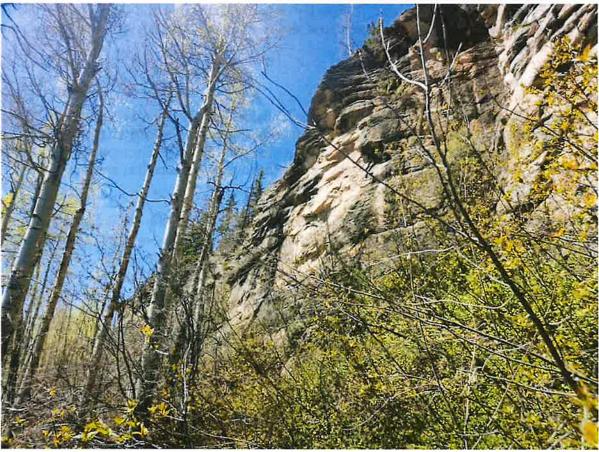
Photograph 1: View of Source Area 1.

The source area at the north end of the site consists of an approximate 50 foot tall cliff exposure of the Hermosa Group sandstone. The source area is roughly 300 to 350 feet up slope from the proposed northern townhome units. The source area was observed to be highly fractured. Evidence of recent rockfall activity along the slope below the source area was observed during our site reconnaissance. A photograph of the source area is provided below.

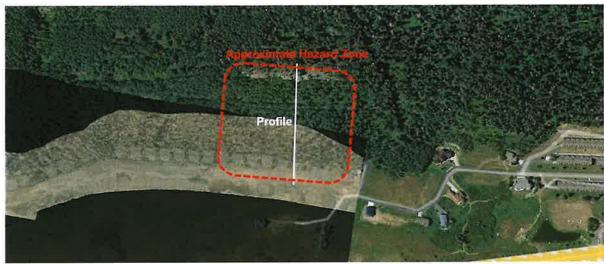
Figure 3.3: Approximate Location of Rockfall Analysis Profile and approximate hazard zone.

We conducted our rockfall analysis using the RocScience RocFall® 2020 (RocFall) rockfall modeling software to predict rockfall behavior at the subject property. The RocFall program is a tool to predict rockfall behavior and to assist in the design of rockfall protection measures. We created a topographic profile using field measurements with a Brunton compass, GPS, range finder and measuring tape. The topographic profile was input into the RocFall model. We utilized RocFall to simulate the existing conditions at the subject property. The RocFall model's input parameters such as surface roughness, vegetation, tangential and normal and dynamic and rolling friction coefficients were manipulated to approximate the existing conditions. Once we were satisfied that we had simulated the existing conditions, we performed numerous iterations of theoretical rockfall with the program while varying sizes and shapes of rocks to model the rockfall behavior at the proposed development. The approximate analysis profile is shown in Figure 3.3

below which also includes the approximate hazard zone. We have also included our RocFall analysis profile as Figure 3.4.

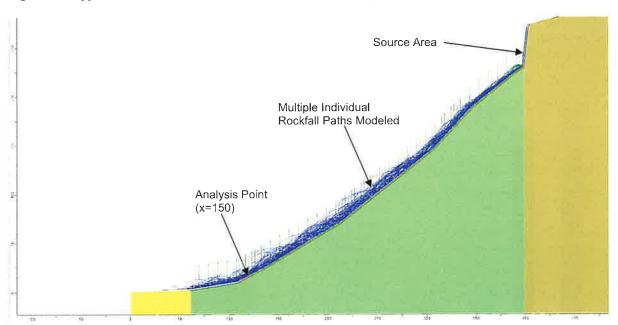
Figure 3.4: Topographic profile used in RocFall analysis.

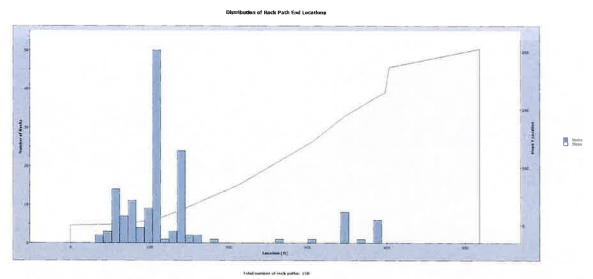
Figure 3.5: Distribution of Rock Path End Locations.

Based on our site observations and analysis, rocks have the potential to move from the source area down to the assumed edge of building sites (X = 150 feet). The approximate hazard zone includes the northern eight townhome units on the current site development plan. This location was chosen as a likely location for rockfall mitigation fencing; however, it must be understood that rockfall impact energy and bounce heigh will vary at different locations along the slope profile. Below, we have provided graphical representation of the estimated bounce heights and total kinetic energy values for various sizes and shapes of rocks observed calculated along the slope. As shown, bounce heights and energy values vary greatly at different points along the slope; however, most rocks were shown reach the development area as shown below on the Distribution of Rock Path End Locations, Figure 3.5.

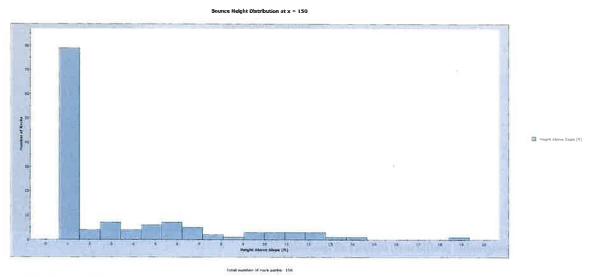
Figure 3.6: Bounce Height distribution table at analysis point (X=150)

At the analysis point, we estimated total kinetic energy of about 200,000 foot-pounds (approximately 270 kilojoules). Bounce heights were highly variable in the model which is fairly typical. Highest values were up to about 19 feet; however of the 130 rocks analyzed that reach the analysis point, 117 (90%) of those rocks have a bounce height of 10 feet or less with the majority (79 rocks) with a bounce height of 1 foot or less.

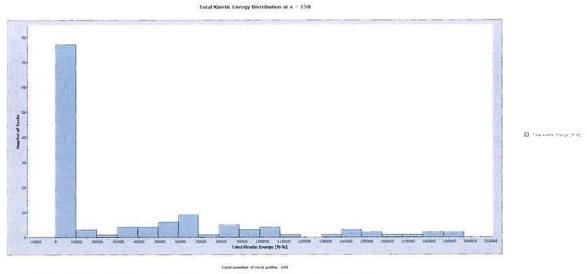
Figure 3.7: Total Kinetic Energy distribution table at analysis point (X=150)

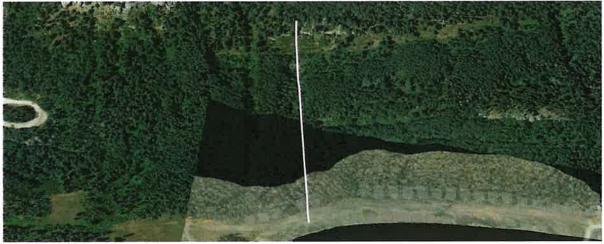
Figure 3.8: Approximate RocFall Analysis Profile.

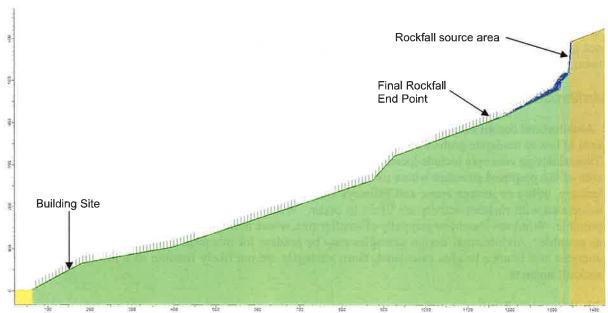
Figure 3.9: Topographic profile used in RocFall analysis.

Based on our site observations and analysis, rocks have the potential to move from the source area down the slope; however, no rocks were modeled to impact the building sites. This analysis is consistent with the observed conditions in the field. Based on our observations and analysis, it is our opinion that the site is not located within a rockfall hazard zone and no mitigation or additional analysis is considered warranted at this time below Source Area 2.

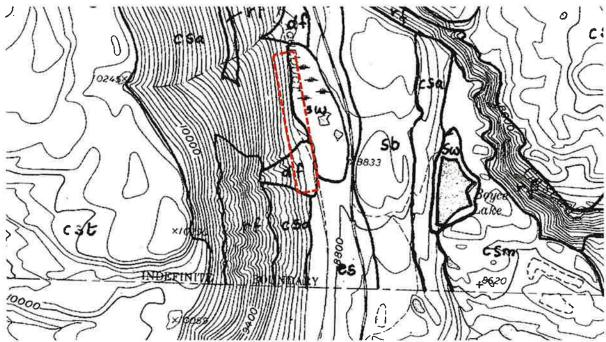
Figure 3.10: San Juan County Geologic Hazard Map Instaar, Engineer Mountain, Colorado, U.S. Geological Survey, June 2, 1976. Approximate project area outlined in red.

Based on our site reconnaissance, and review of available literature, the southern portion of the site is located within a potential debris flow hazard area. The hazard area is generally located in the same drainage feature as the avalanche hazard risk area identified in Section 3.1 above which is not uncommon. Basic geologic hazard mapping is available from San Juan County and is provided below showing the approximate project extents in red.

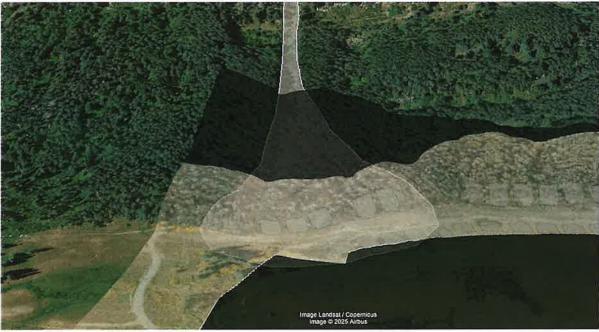
Figure 3.11: Debris flow and fan hazard area outlined on the site schematic.

We performed a site reconnaissance of the potential debris flow area and outlined some approximate boundaries of the potential hazard zone. It must be noted that the schematic provided below should be considered appropriate and does not constitute a full engineering debris flow analysis including extent, deposition depths and flow velocities, which may be required for development in this area. There are engineering firms who specialize in these analyses.

We did not observe any recent debris flow activity within the hazard zone; however, the site represents a classic debris flow zone with debris fan. The hazard zone originates within a channel up slope, just north of another cliff band south of the site. The channel flows into a wide debris fan with hummocky terrain characterized by abundant boulders that are imbedded in the historic deposition area. A schematic showing the approximate extent of the debris fan is provided below. A similar number of units are potentially affected by the debris flow hazard as was affected by the avalanche hazard. Roughly the southern 10 units are affected. If development is planned in this area a debris flow specialist should be consulted.

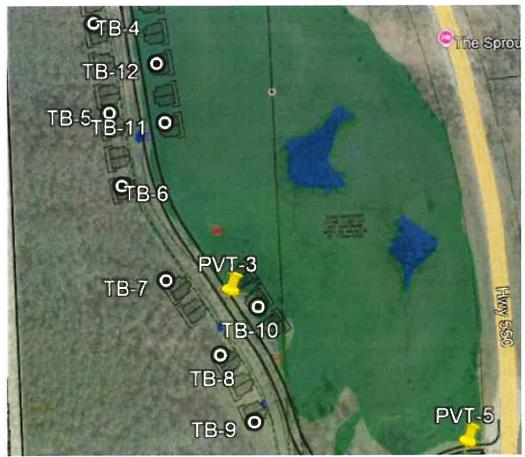
Figure 3.10: Locations of Exploratory Borings.

Mine sites in the region likely present the highest risk areas for ground subsidence. No known mine adits or subsidence prone materials exist at or under the project site. There is no evidence of ground subsidence at the project site. Very low strength wetland soils encountered at the site may also pose a risk of ground subsidence specifically in the vicinity of Borings TB-10, -11 and -12 in our Geotechnical Engineering Study as shown below.

Structures located in wetland areas on the east side of the main access road have low strength soils which are prone to settlement under foundation loads. Therefore, as noted our earlier study, these structures should be supported with deep foundation systems supported by the underlying formational materials. Typical shallow foundation systems are not suitable for support in these areas.

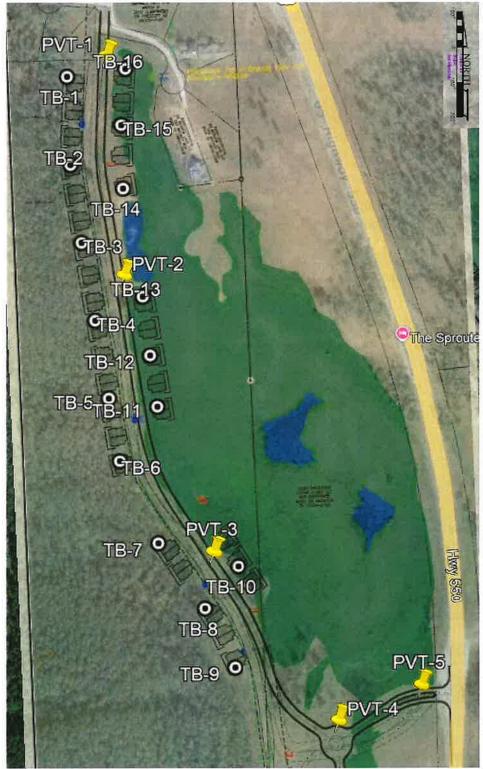
Figure 1: Locations of Exploratory Borings. Adapted from a site plan prepared by CHC Engineers LLC.

The schematic presented above was prepared using notes and field measurements obtained during our field exploration and is intended to show the approximate test boring locations for reference purposes only.

We advanced sixteen test borings in the vicinity of the proposed structures and five shallow test borings in the vicinity of the proposed roadways. A schematic showing the approximate boring locations is provided below as Figure 1. The logs of the soils encountered in our test borings are presented in Appendix A.
