## Application for Improvement Permit

### **Proposed Collins Residence**

Hwy 550 San Juan County, Colorado  
(Greyrock Village North)  
37.62 Acres Located in Section 13  
Township 39 North, Range 9 West

**Subject: Application for Land Improvement Permit - Plan Review**

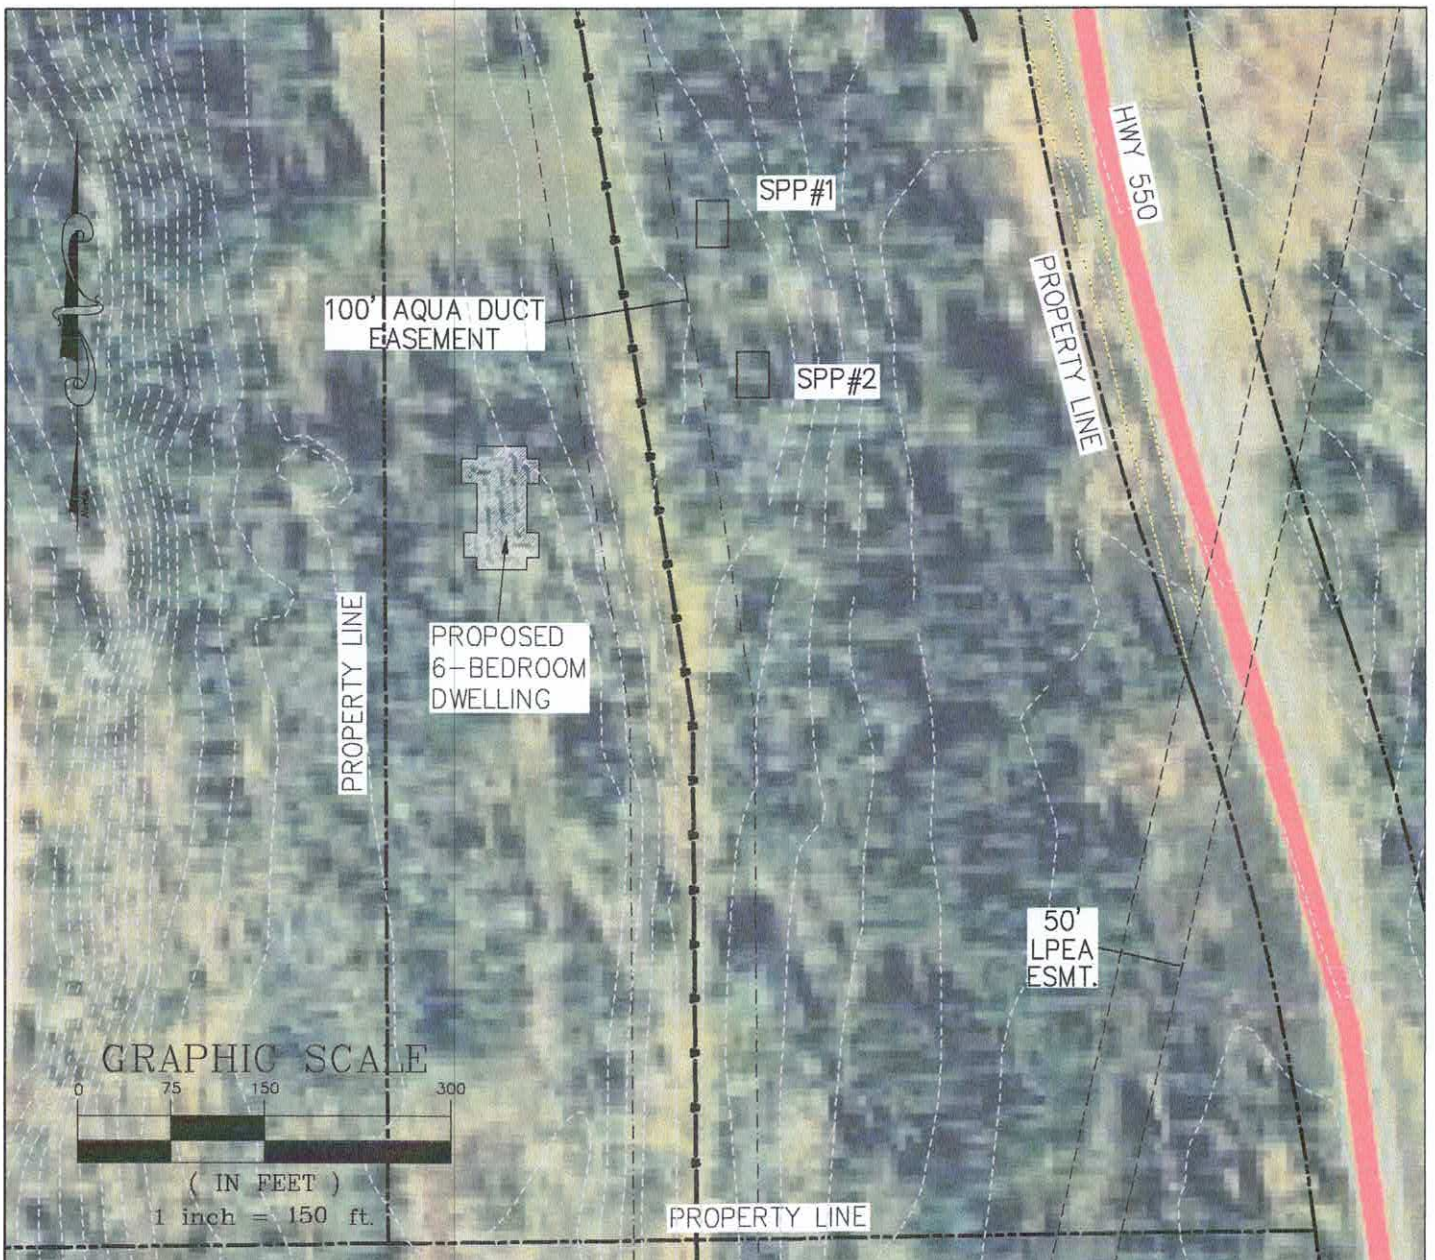
**SOIL TREATMENT AREA DESIGN CALCULATIONS:**

A PRESSURE DISTRIBUTION, UNLINED SAND FILTER SYSTEM IS PROPOSED USING ELJEN END DRAIN MODULES OVER 12" OF CONCRETE SAND FOR TREATMENT LEVEL 2.

Daily sewage volume:  $Q_s = 2000$  gal/day  
 Allowable soil loading rate:  $Q_c = 0.8$  gal/sq. ft. /day  
 Total soil area required:  $A_T = 2500.0$  sq. ft.  
 Trench (0.8 Factor) \_\_\_\_\_  
 Bed bottom area required: 2500.0 sq. ft.  
 Geotextile Sand Filter (0.9) \_\_\_\_\_  
 Infiltrator (0.7) \_\_\_\_\_  
 Bed bottom area required: 2500.0 sq. ft.  
 Lateral width:  $T_w = 12$  ft      104 Eljens  
 Bed length:  $L = 208.0$  ft.      Eljens 2 rows L      Eljens 1 row L  
 Number of Rows: 3.0      17      68      18      72  
 Total length of rows:  $T_L = 416.0$  ft.  
 Orifice spacing:  $O_s = 4$  ft.  
 Number of orifices:  $N_o = 104$   
 Orifice diameter:  $O_o = 1/8$  inches  
 Lowest level in dose tank: 8850.0 ft.      18.875  
 Highest drainfield lateral: 8840.0 ft.  
 Orifice head:  $H_o = 10.0$  ft.  
 Orifice discharge rate:  $Q_o = 0.60$  gal/min  
 Siphon discharge rate:  $Q_s = 63$  gal/min

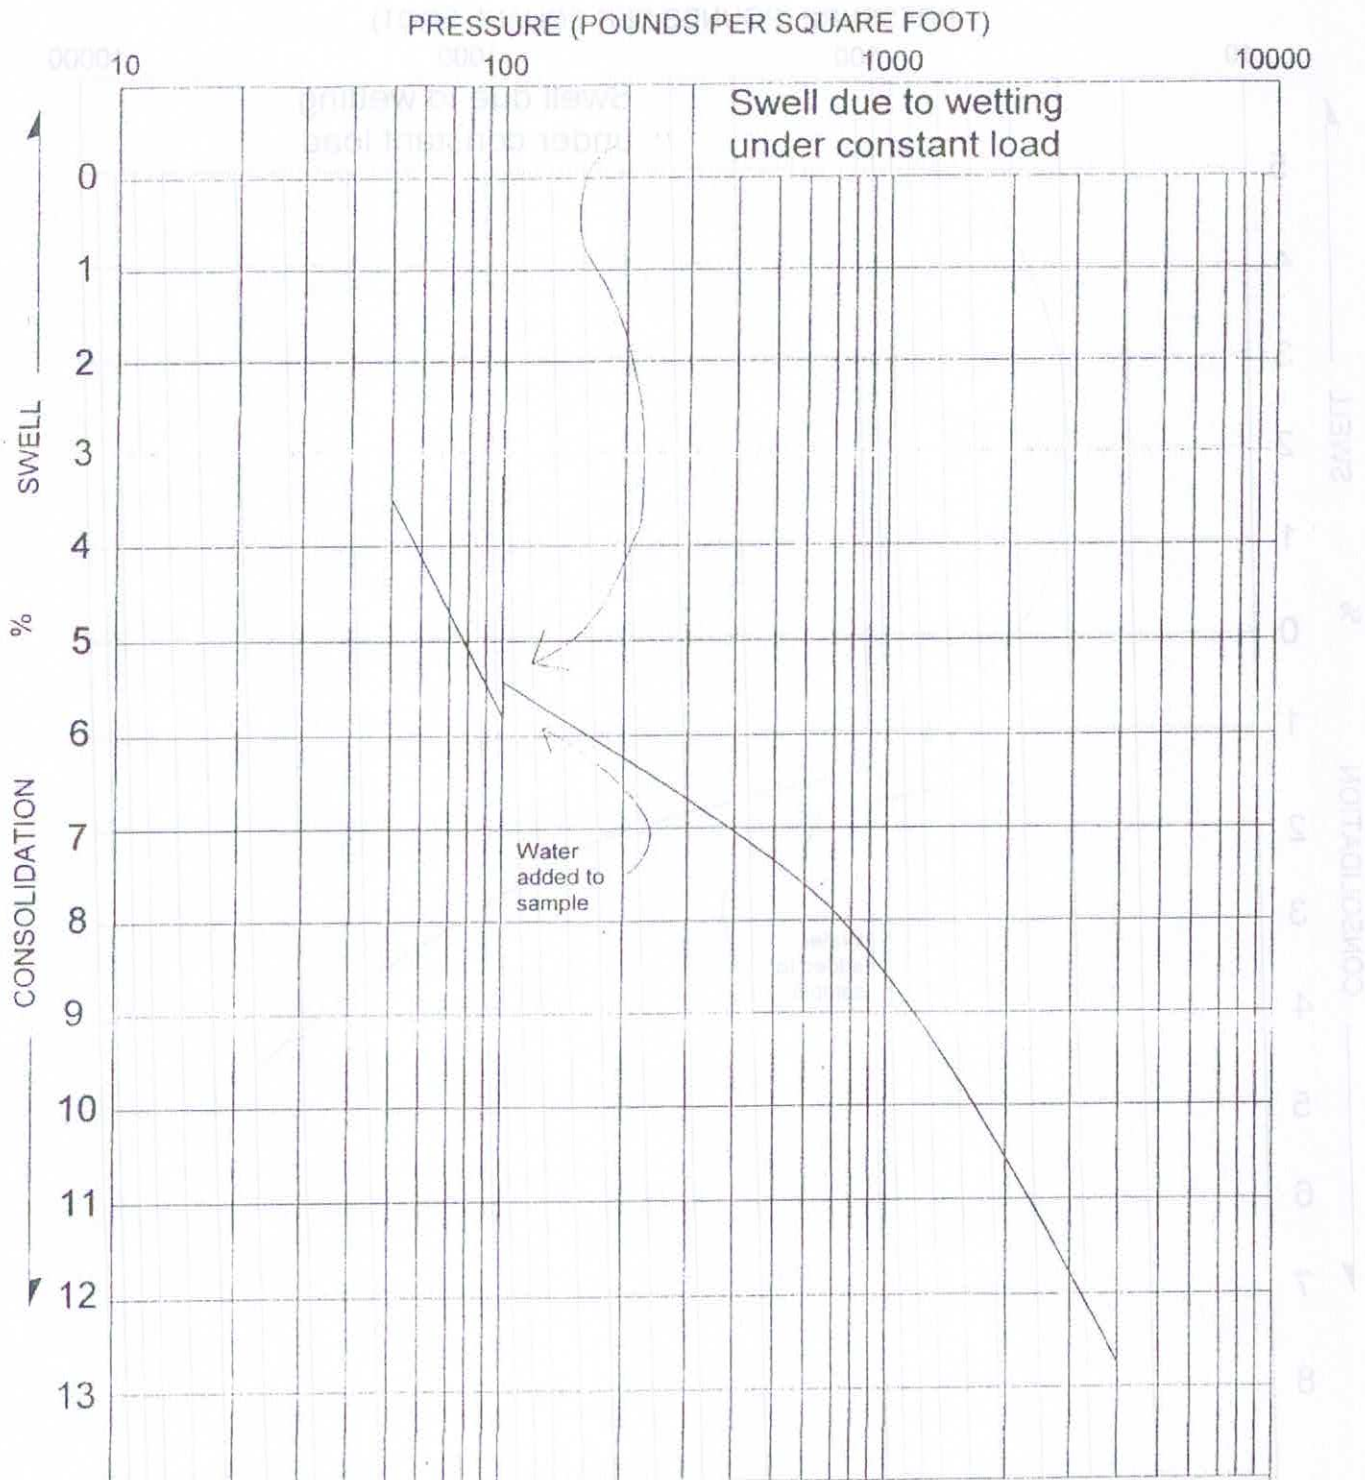
Figure: B9

SUMMARY OF TEST RESULTS					
Boring No.	Moisture Content (%)	Dry Density (P.C.F.)	Height (in.)	Diameter (in.)	Swell Pressure (P.S.F.)
Twenty-eight (28)					
Depth 4.5-9.5 feet					
Initial	21.0	84.3	1.000	1.94	200
Final	33.2	83.0	0.873	1.94	
Soil Description	Silt, sand, dark brown, moist, organics

**SWELL - CONSOLIDATION TEST**
